Silicon Detector Challenges

For the Nab Detector Review

October 26, 2023

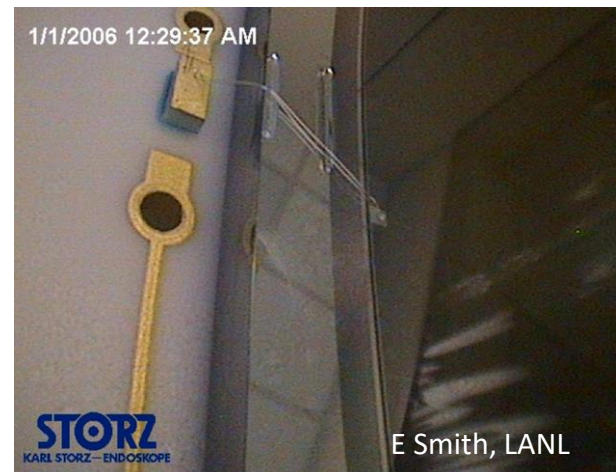
Intact Wirebond

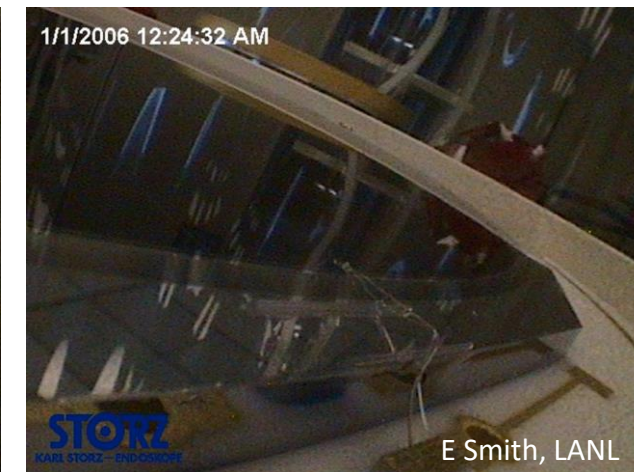
- Thermal cycles break the wirebonds
- Possible causes:
 - Uneven stress on detector ceramic causing flexing?
 - Wirebonds too tight?
- Assessment from T. McKnight (ORNL):
 - "There is insufficient LOOP of the wire from the bonding pad on the wafer to the exterior wirebonding posts"

Broken Wirebond

- There is insufficient LOOP of the wire from the bonding pad on the wafer to the exterior wirebonding posts. The wire therefore is tensioned across the edge of the wafer and this is imparting stress to the wire (particularly if there is any differential thermal expansion after the bond is made) and pulling the wire off typically at the pad on the wafer, but also sometimes on the exterior post. The bend in the wire caused by this can be seen at 3 of the 4 quadrants.

- Solution is to provide more loop to the wire such that it does not interact with the edge of the wafer. If the wirebonder LOOP settings do not provide sufficient loop, then a manual process can be used whereby you drag the bonder beyond the target pad and then move back to the target pad prior to making the second bond. This will feed additional wire to provide sufficient loop.

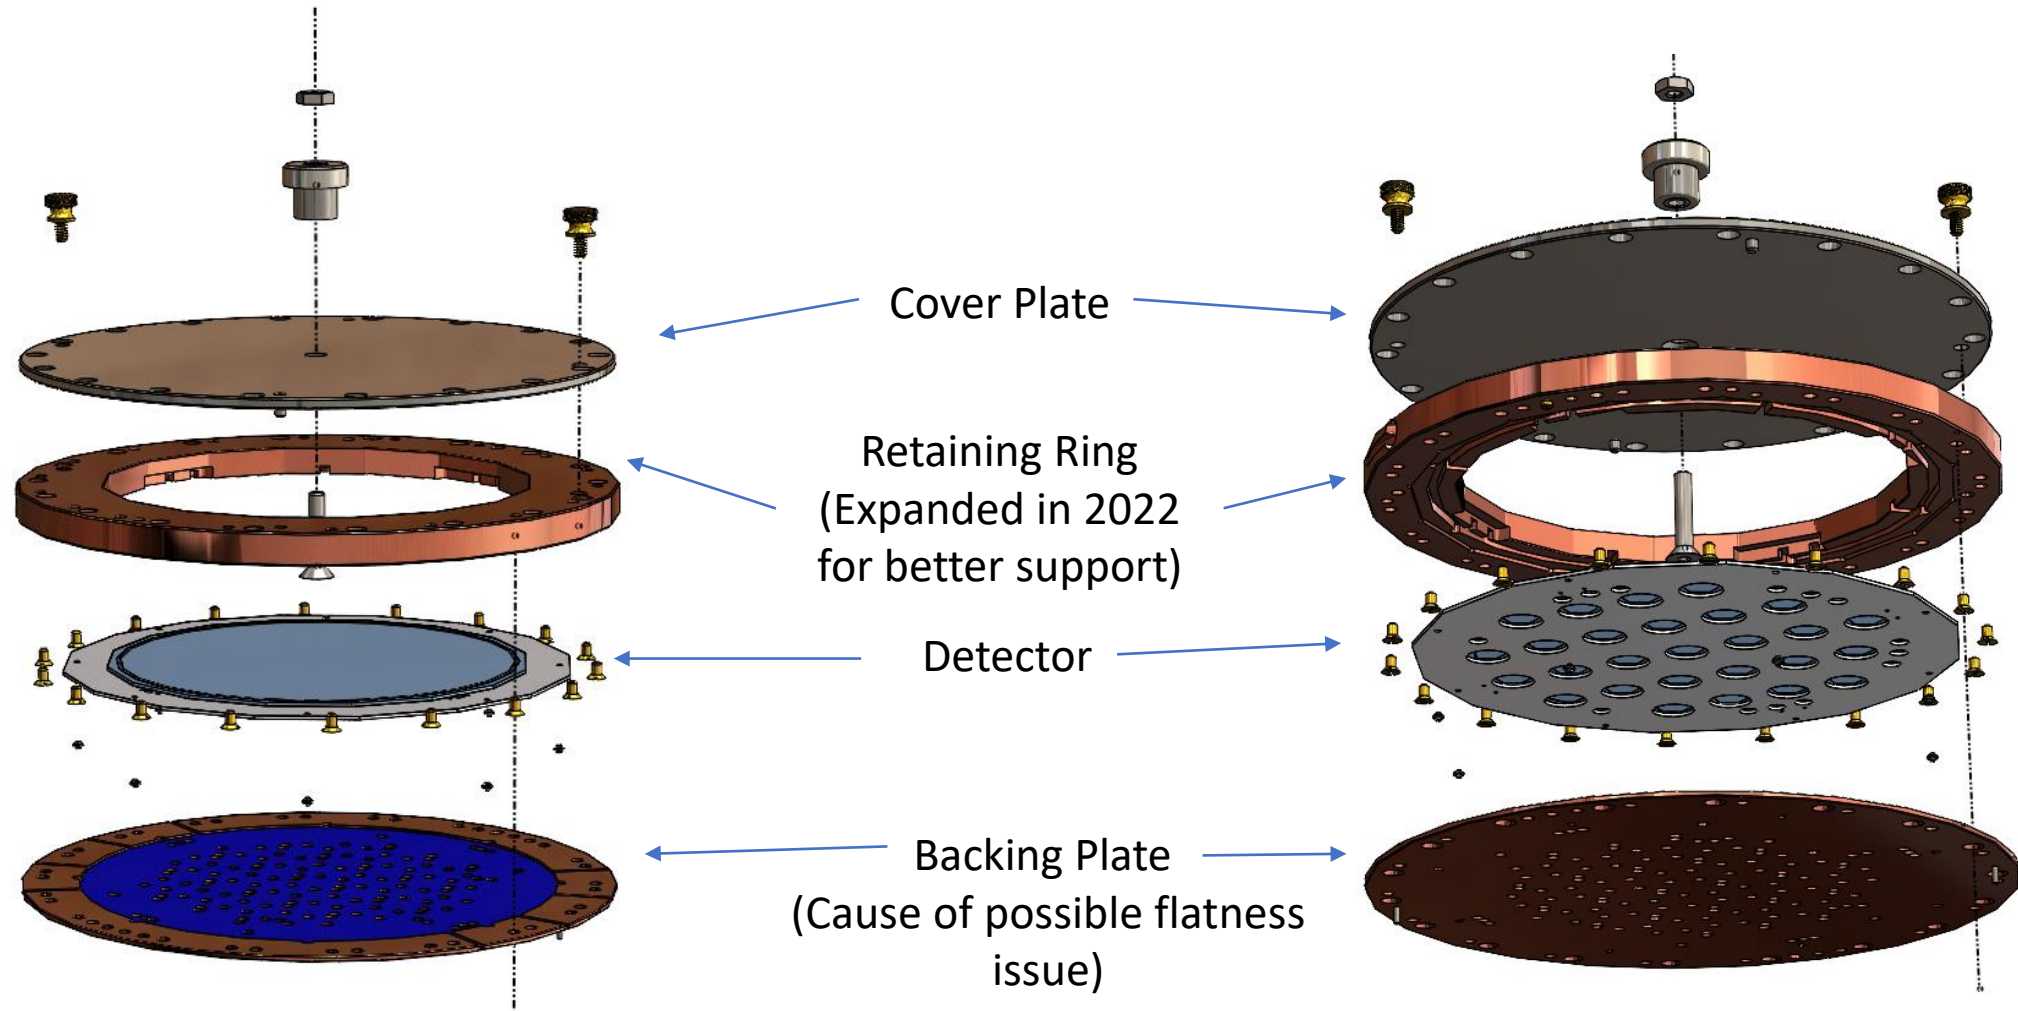
Re-machined Detector Armor

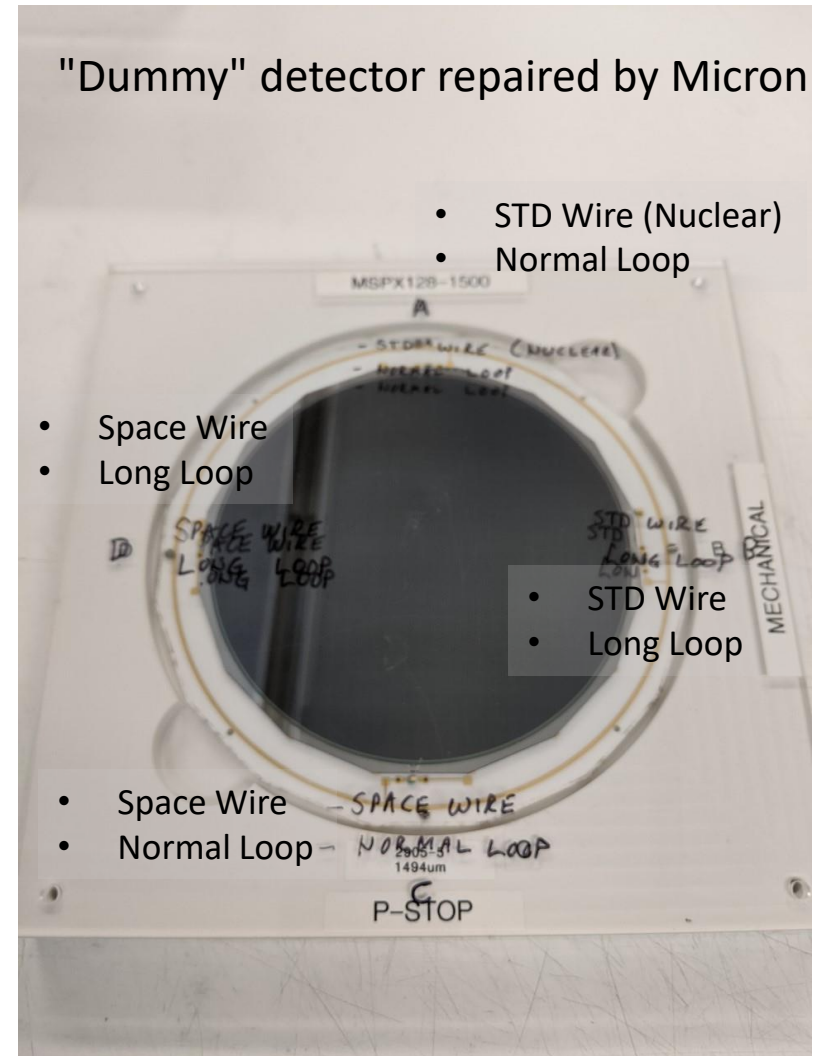
Re-done Wirebonds

- Repaired wirebonds with more slack
- Repairs done at both Micron and ORNL (Tim McKnight)
 - Micron repairs slow (~2 years, but during COVID-19)
 - Tim has retired
- Combination of repaired wirebonds and new armor has survived many thermal cycles
 - Only have 1 “good” detector with wirebond modification

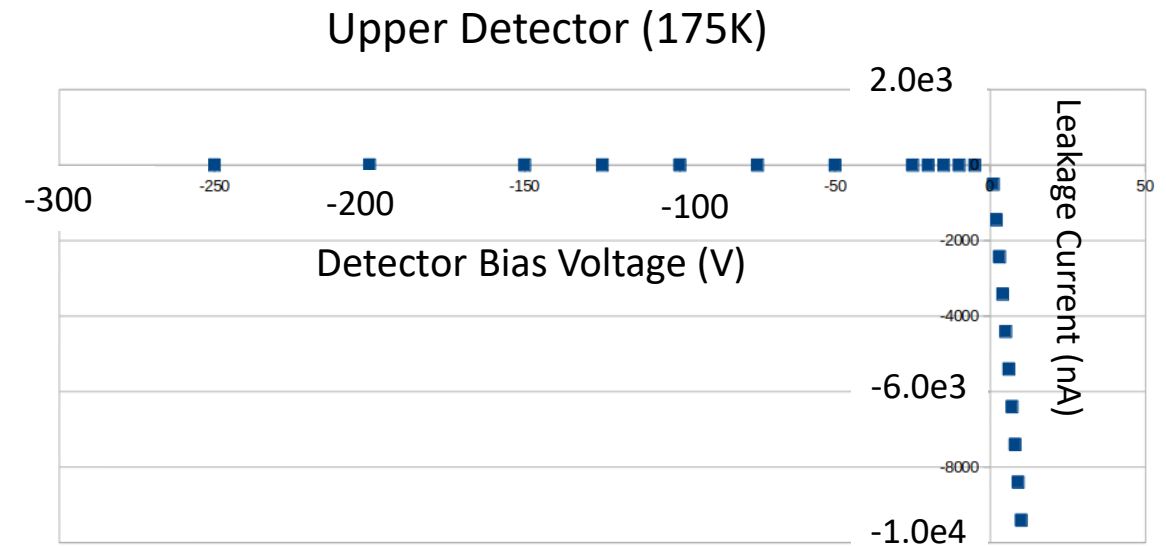
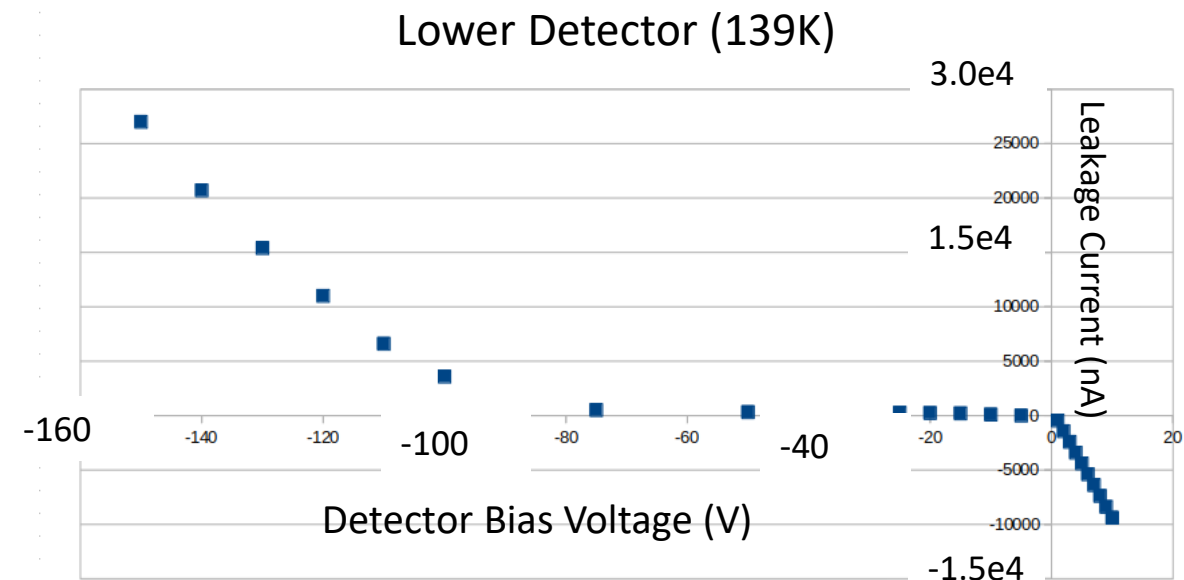
- Two detectors installed into spectrometer
 - Upper detector underwent extensive testing at Manitoba
 - Lower detector installed with wirebonds recently repaired by Micron
 - No low temperature or source tests on lower detector due to long turnaround
- After installation of lower detector:
 - Anomalously high leakage current
 - Negative pulses (assume from detector breakdowns – surface contamination?)
 - Prevents operation above -50V bias

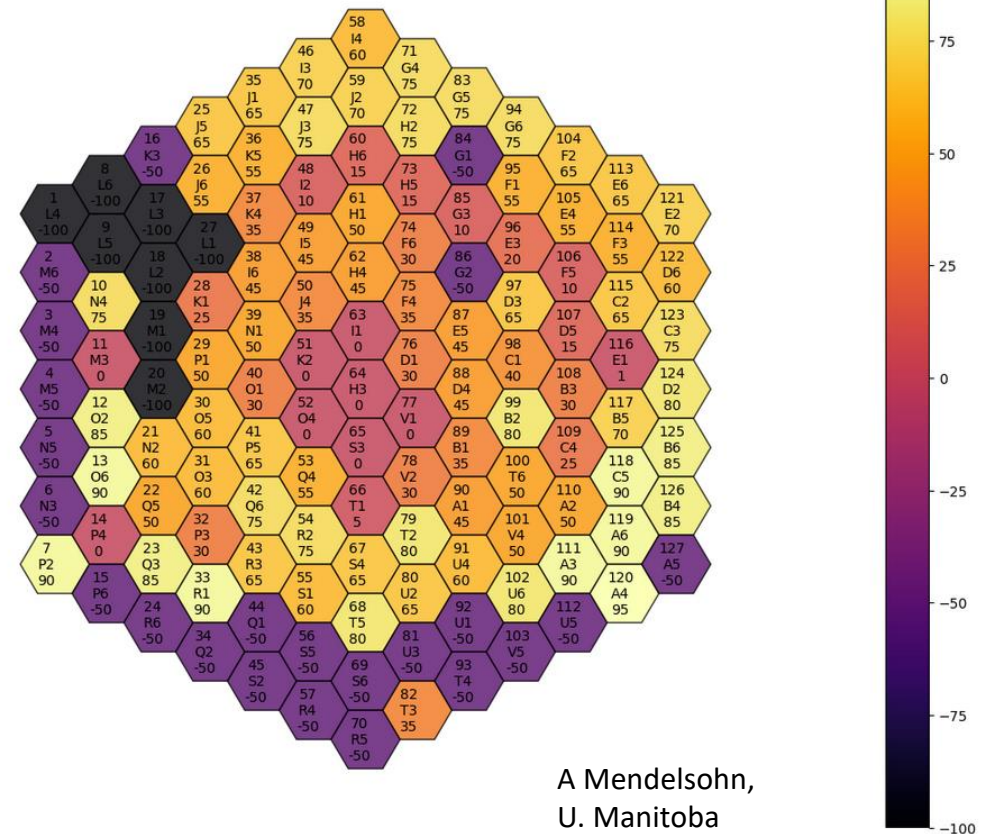
- Unable to fully bias detector before overwhelmed by noise
 - Ran at -50V for most data-taking
 - Distortion in waveform shapes
 - Not all pixels active!

Lower Detector Pixel Turn-on Bias Voltage

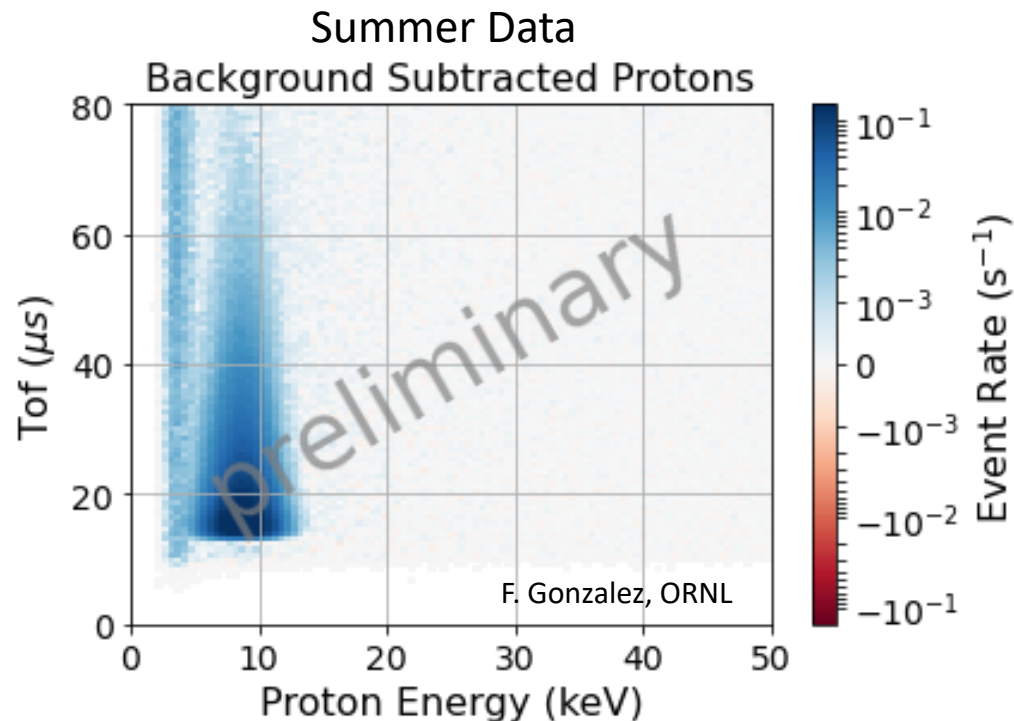
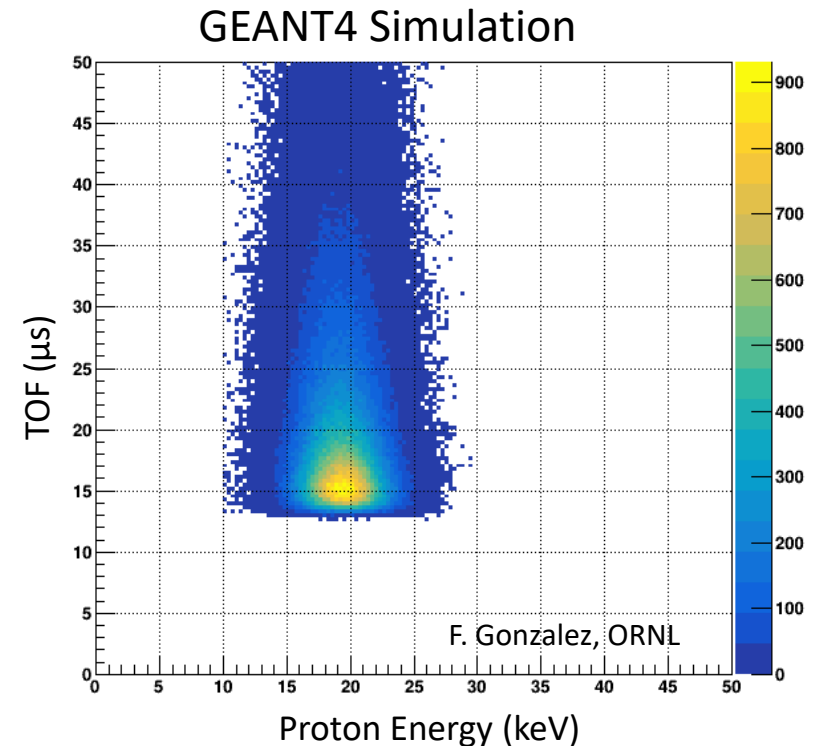
- Recall: Protons accelerated to detector by 30 kV accelerating potential
 - Expect to see proton peak from 30 keV protons at ~ 19 keV given 100 nm Si deadlayer (ideal case)
 - See peak ~ 2 x lower than expected (but still working on low energy calibration)

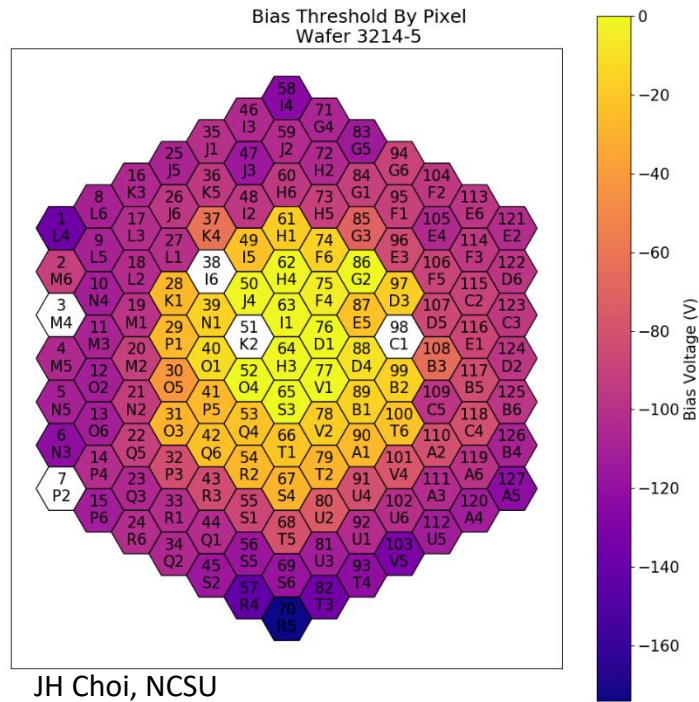
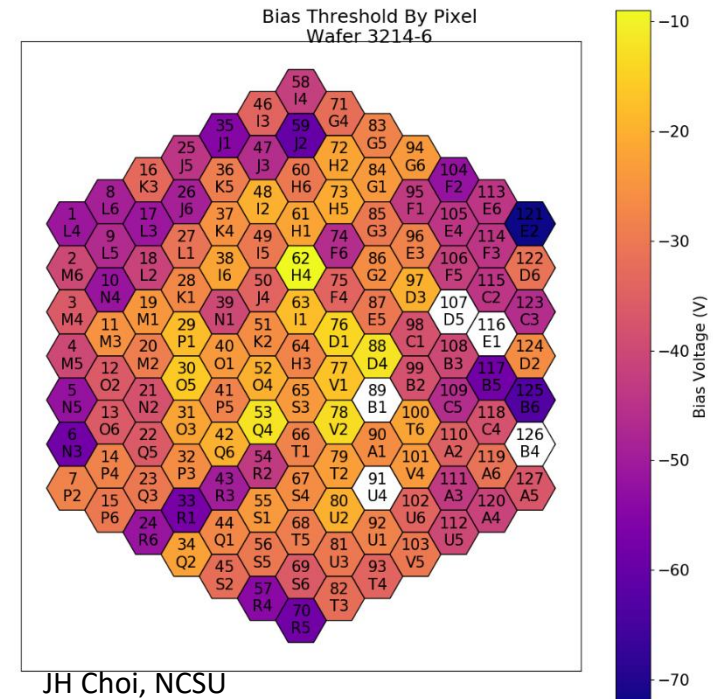
“Turn On” Voltage Studies

- “Turn on” is point when the pixel starts to produce realistic pulses on the scope.
- The maximum voltage is comparable to the stated depletion voltage measure by Micron.
- Initial discussion with Micron about the patterns was not very enlightening, but as we test more detectors we hope to identify the source of the variation. These two detectors did have slightly different processing.
- White pixels indicate no data – usually due to connectors or damaged FET channel

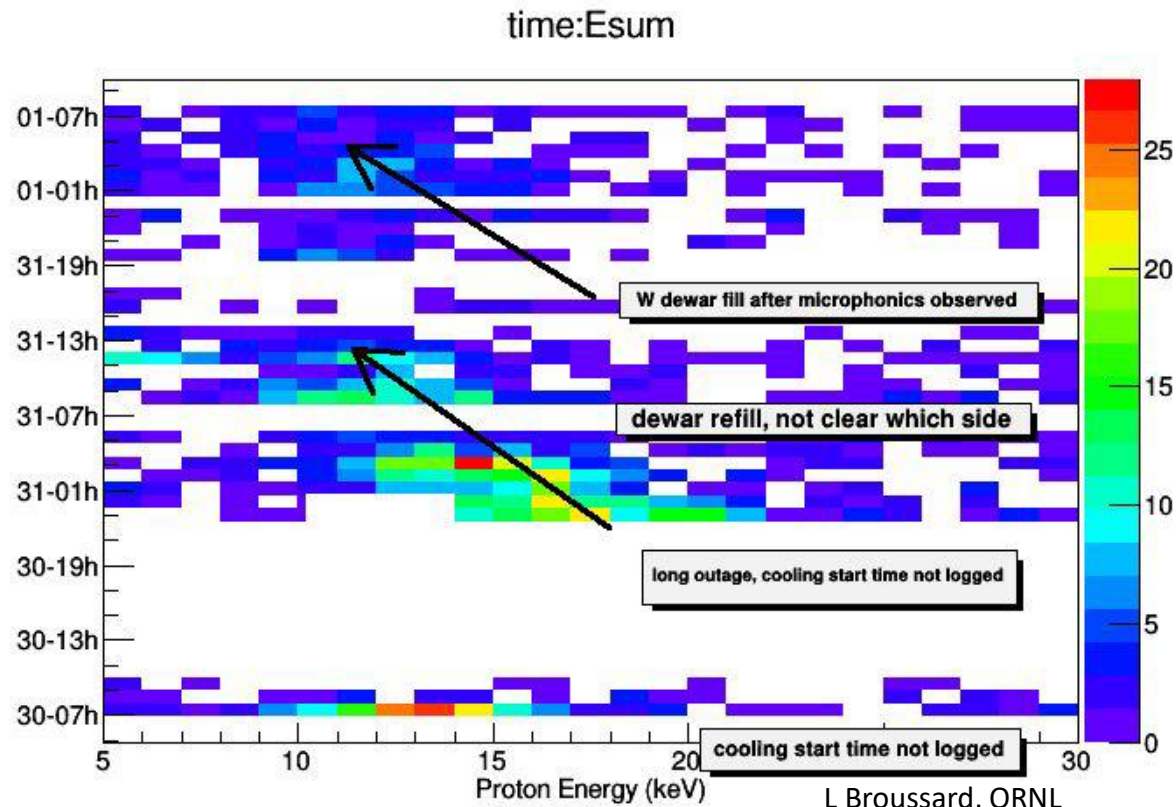
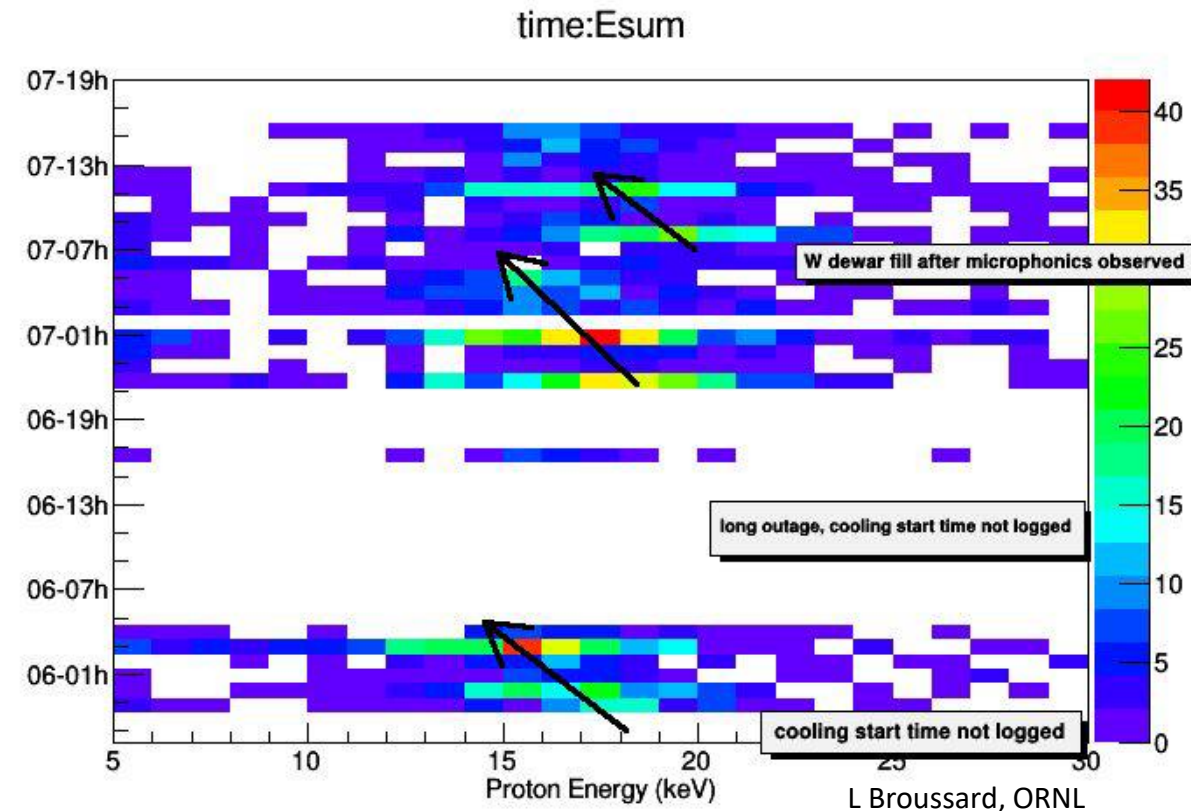
Observations from LANL prototype

- Expected proton energy w/ 100 nm Si = ~ 19 keV
- Expected proton energy w/ 100 nm Si + 70 nm ice = ~ 14 keV
- LANL pressure = $5e-7$ mbar. Protons lose ~ 5 keV per ~ 12 hours

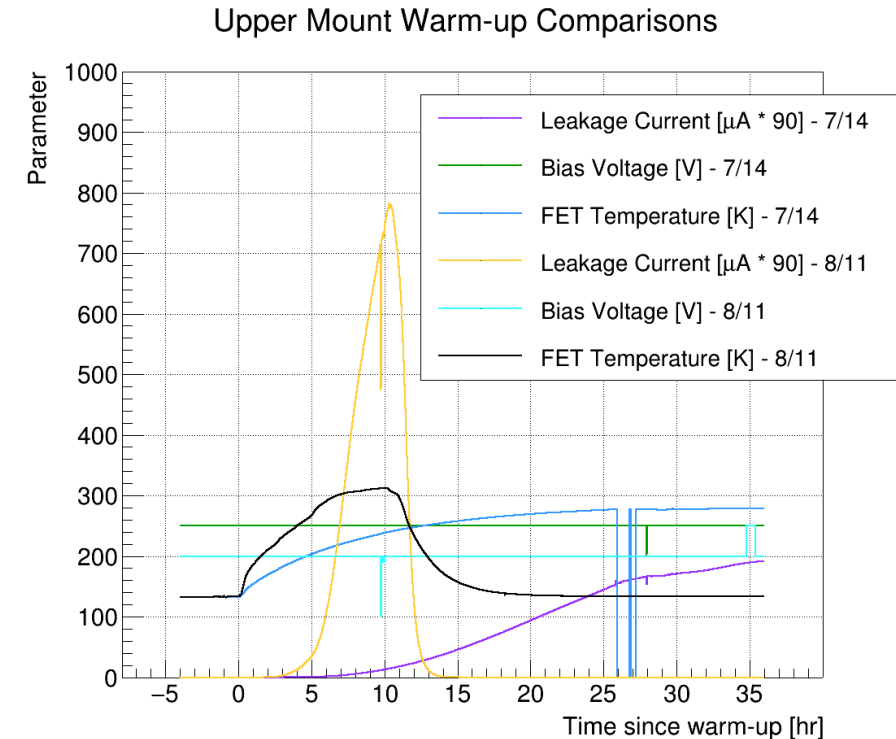
Fast Detector Warmup at ORNL

- Before summer data-taking, at FET temp 288K and -200V , $I_L = 3.3 \mu\text{A}$
- After too-low proton energy observed, attempted warmup of detector to remove ice
 - Note: no working detector temperature sensor, FETs previously within 10K of detector, but detector has much slower time constant (several hours slower to stabilize)
 - Used detector leakage current. Warmed up to $I_L = 8.6 \mu\text{A}$ (at 200V).
 - Aborted warmup due to concerns about magnet temperature (quench risk)
- No change in detected proton energy after warmup
