# Connector Improvements

Chuck Britton, Nance Ericson, Kyle  
Reed, Emma Brown, Leah Broussard,  
Austin Nelson, Andrew Hagemeyer

8 Feb 2023

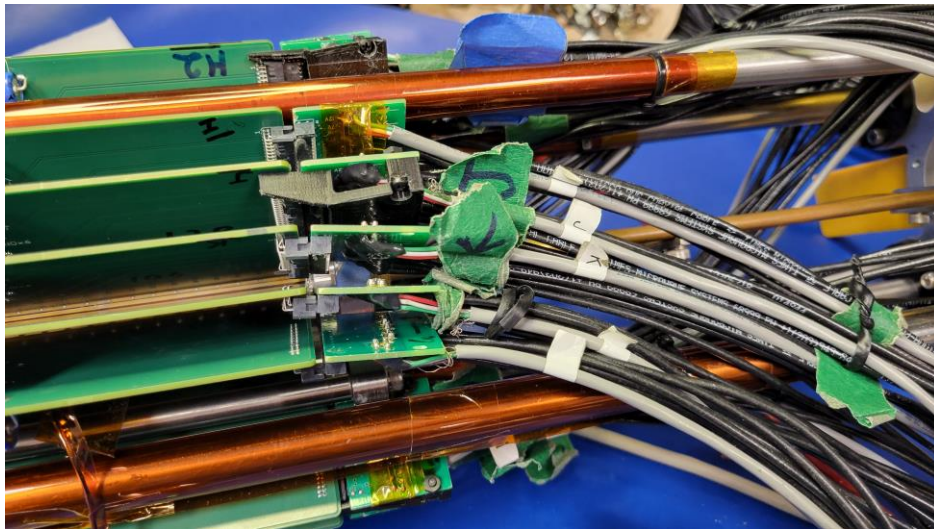
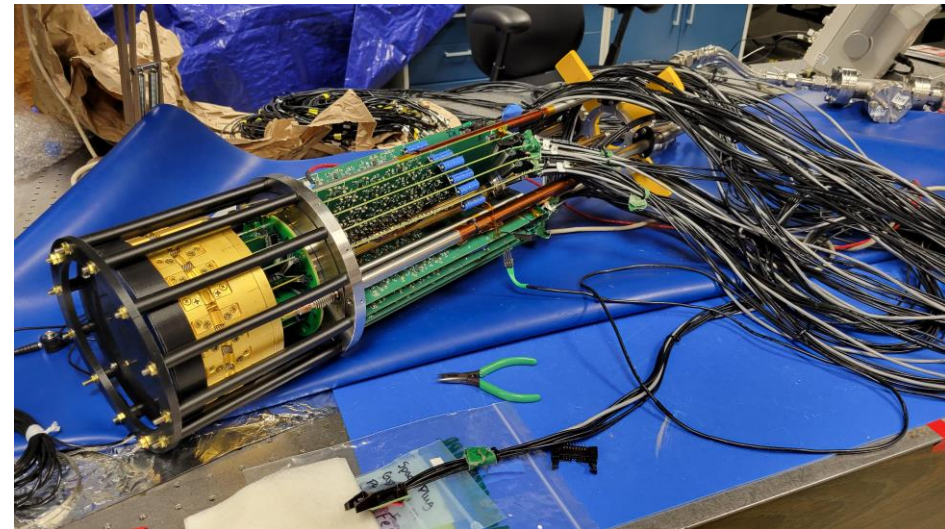
- Connectors have severe retention issues
  - Fall out easily
  - Slight movement causes partial or complete disconnection
  - Hard to put in for installers
- Connector is not appropriate for the signals
- Need to change to a connector or cabling that is more robust

Too small connector, too many grounds, easy to dislodge

- Two approaches have been considered
  - 1<sup>st</sup> would be to use a heavier-duty right-angle header with 0.1" pin spacing
  - This would allow cables to be connected requiring much more force and therefore more retention
  - Also would have better ground
  - 18" pigtail cables would then be connected to these prior to installation making assembly much easier
  - 2<sup>nd</sup> would be to solder pigtail cables directly to each board.
