^{60}Co γ Irradiation of a CMS CROC v2 to 1.6 Grad

VERTEX 2025
Knoxville, TN
August 25-29, 2025

Steve Wagner (University of Colorado, Boulder)
For the CMS Tracker Project

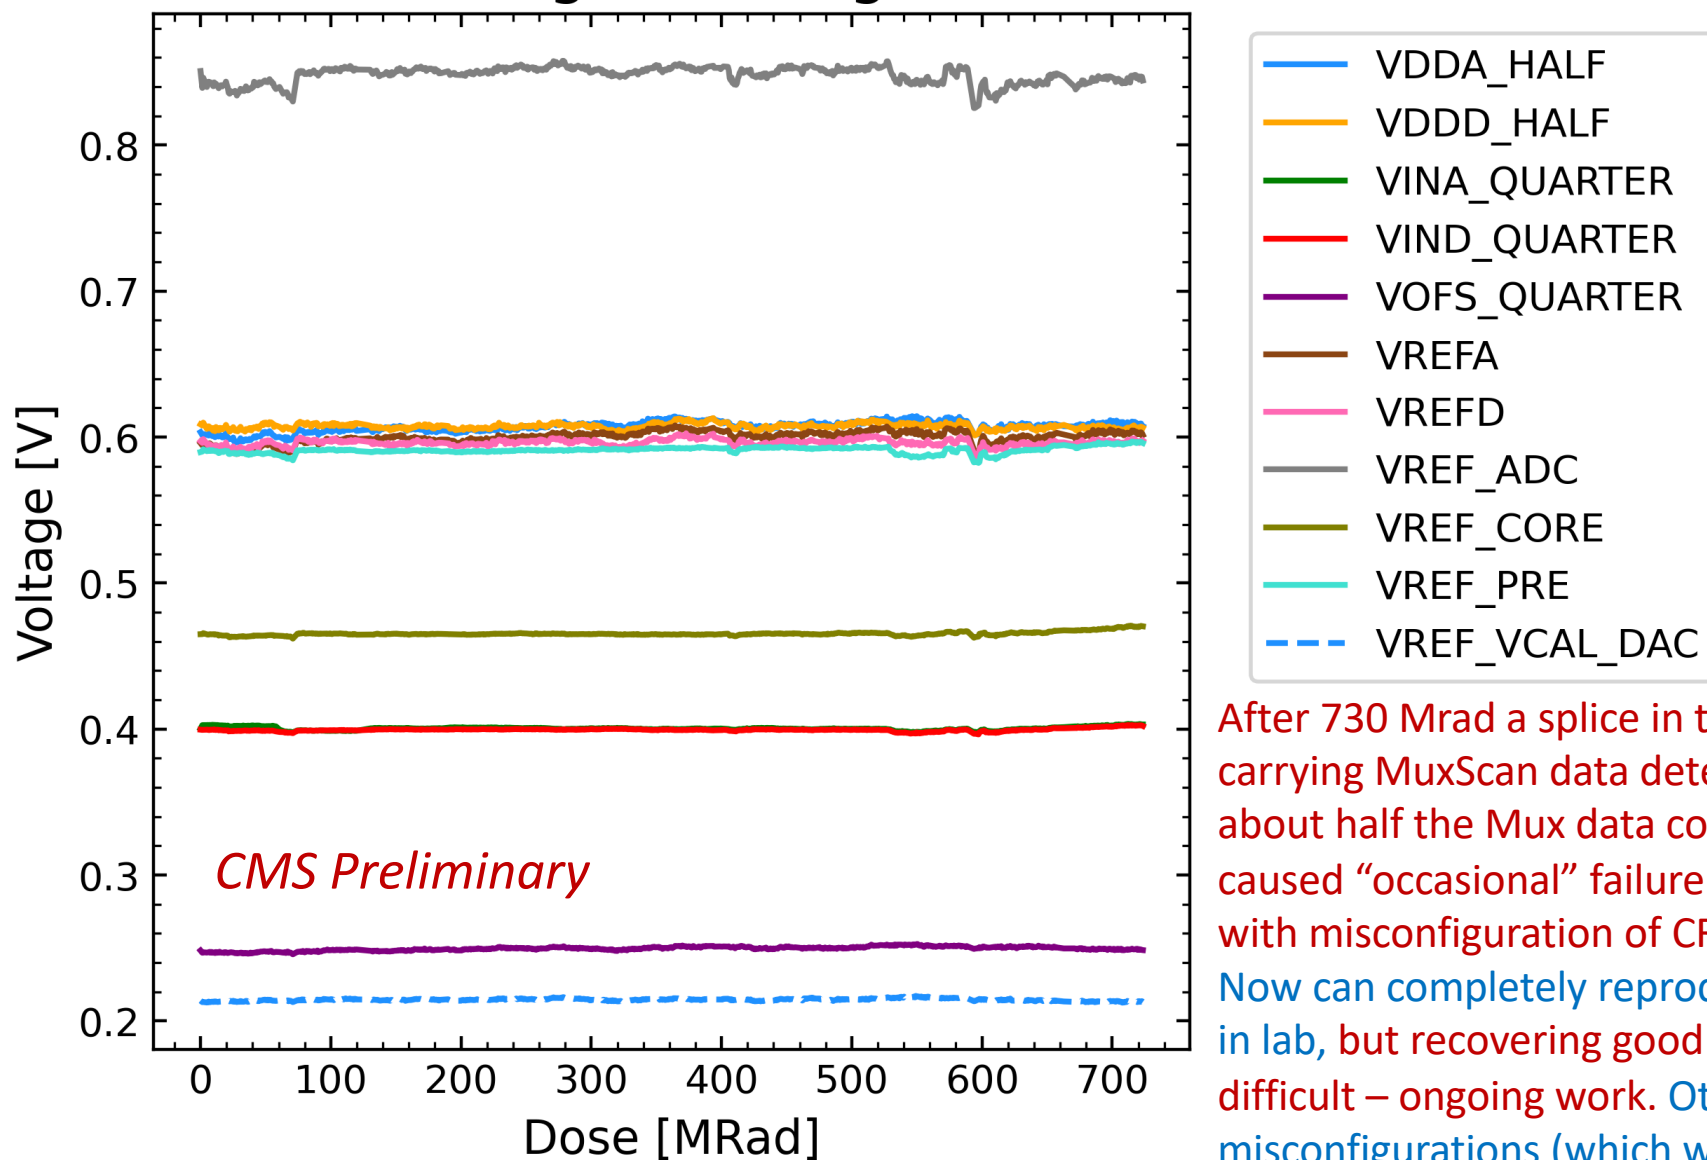
External Voltages During Irradiation

After 730 Mrad a splice in the cable carrying MuxScan data deteriorated, & about half the Mux data corrupt. Also caused "occasional" failure of MuxScan with misconfiguration of CROC voltages. Now can completely reproduce problems in lab, but recovering good data is difficult – ongoing work. Other than misconfigurations (which were reset) did not affect operation of CROC

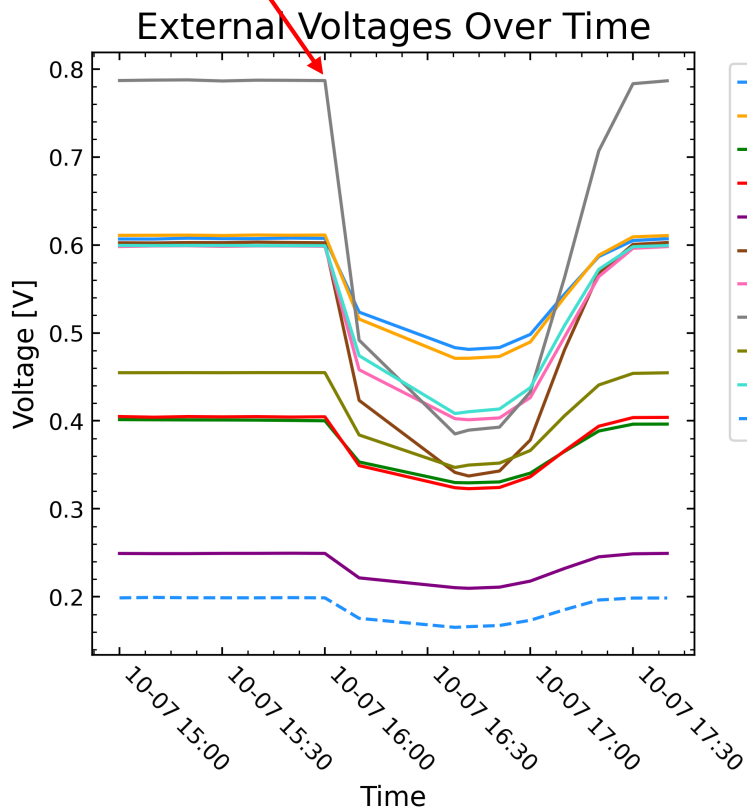
Voltages from MuxScan do not represent (or affect) Voltages on CROC when splice wet

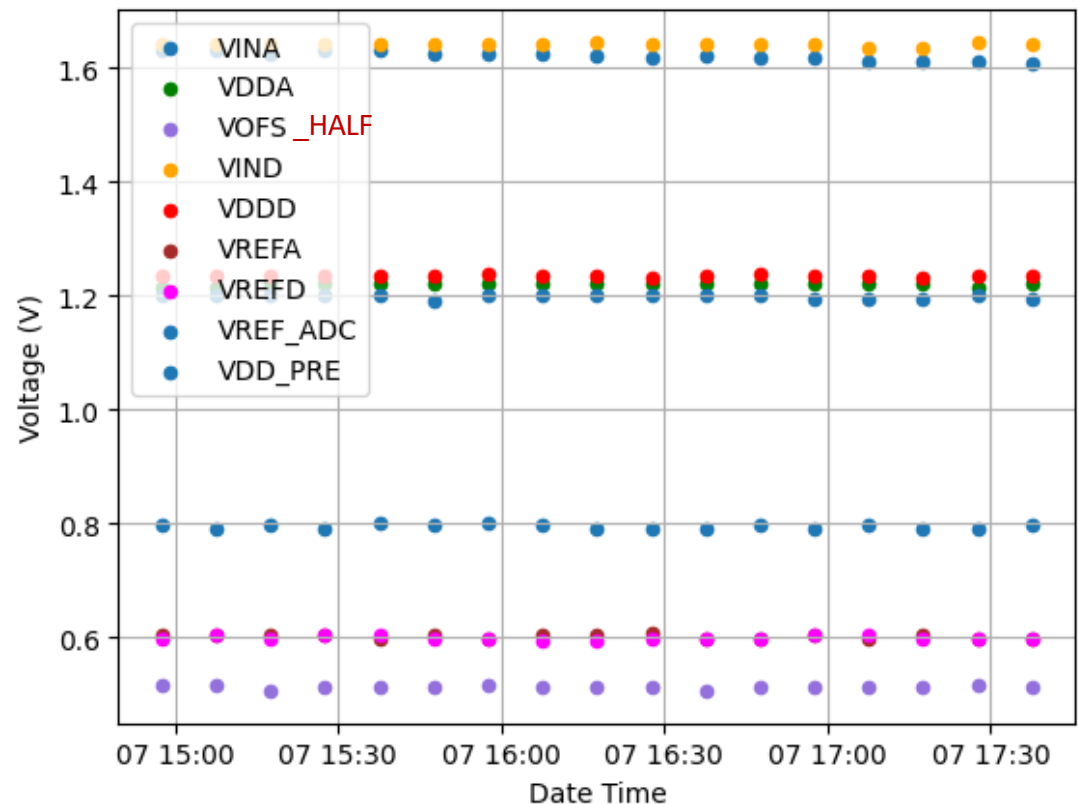
Voltages read off pin block at the same time

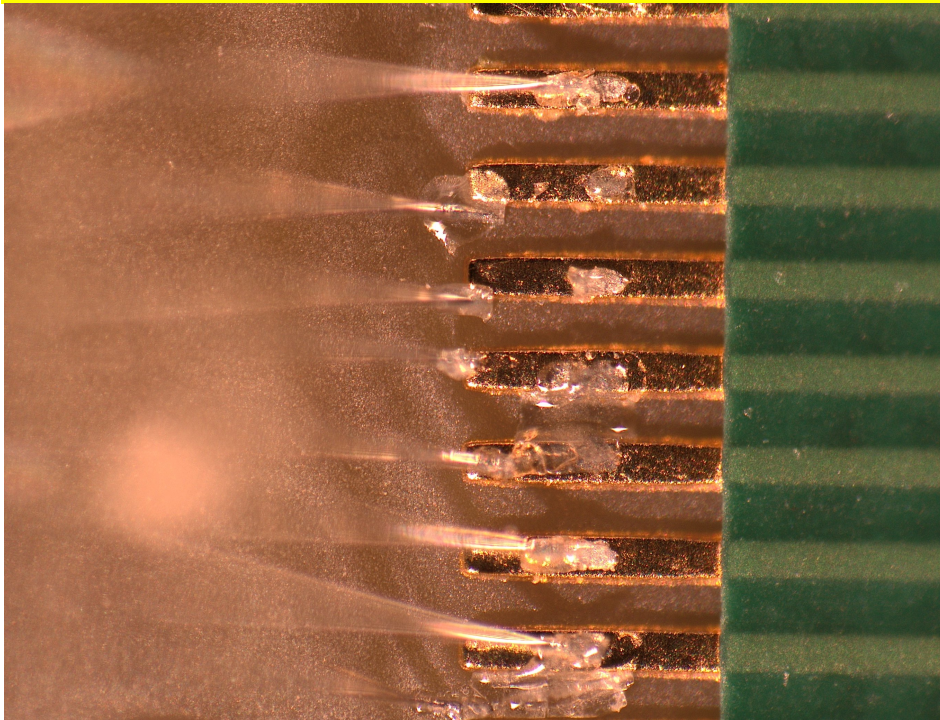
SD5 wire bonds looked “OK” after 300 Mrad irradiation in Jan 2024 but began deteriorating quickly, so the CROC stopped working ~ 1 month after irradiation ended

Saw same thing after pause in Jan 2023 irradiation (at 100 Mrad) – actually kept us from restarting that irradiation

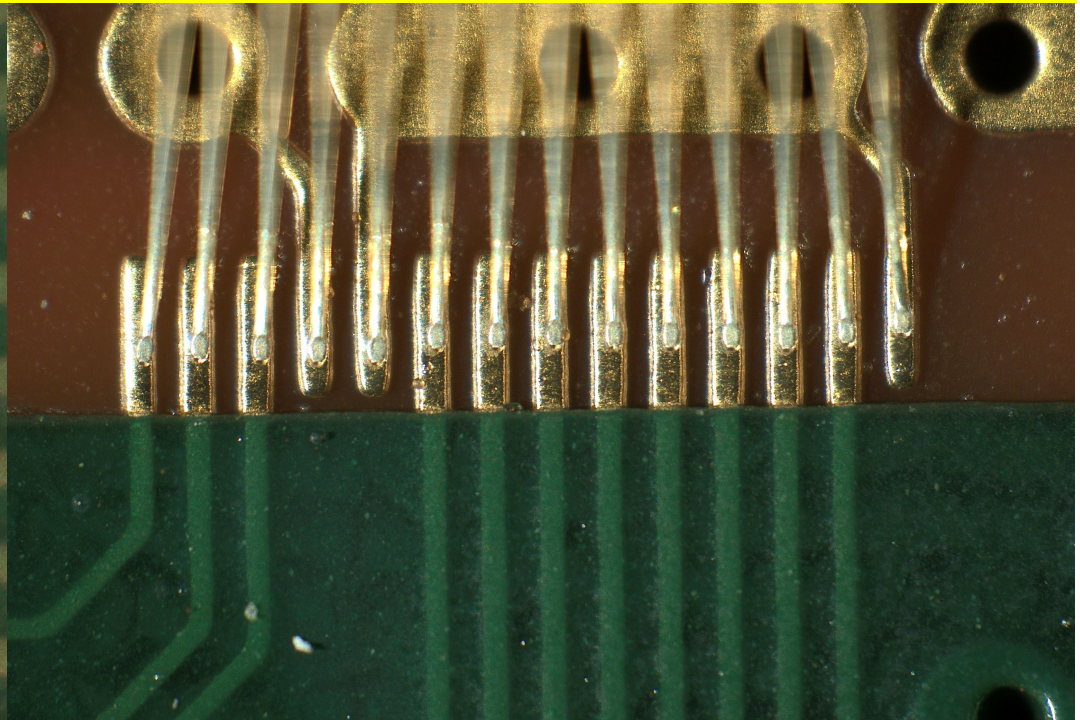
SD22 wire bonds look as good as they did before the irradiation – examined all ~200 & not one that looks problematic (photo 2 months after irradiation but still good ~ a year later)

And they were probably exposed to as much hazard after 1600 Mrad irradiation ended (heat & loss of positive pressure for ~60 hours) as they were during the irradiation – give credit to₂₄ parylene coating

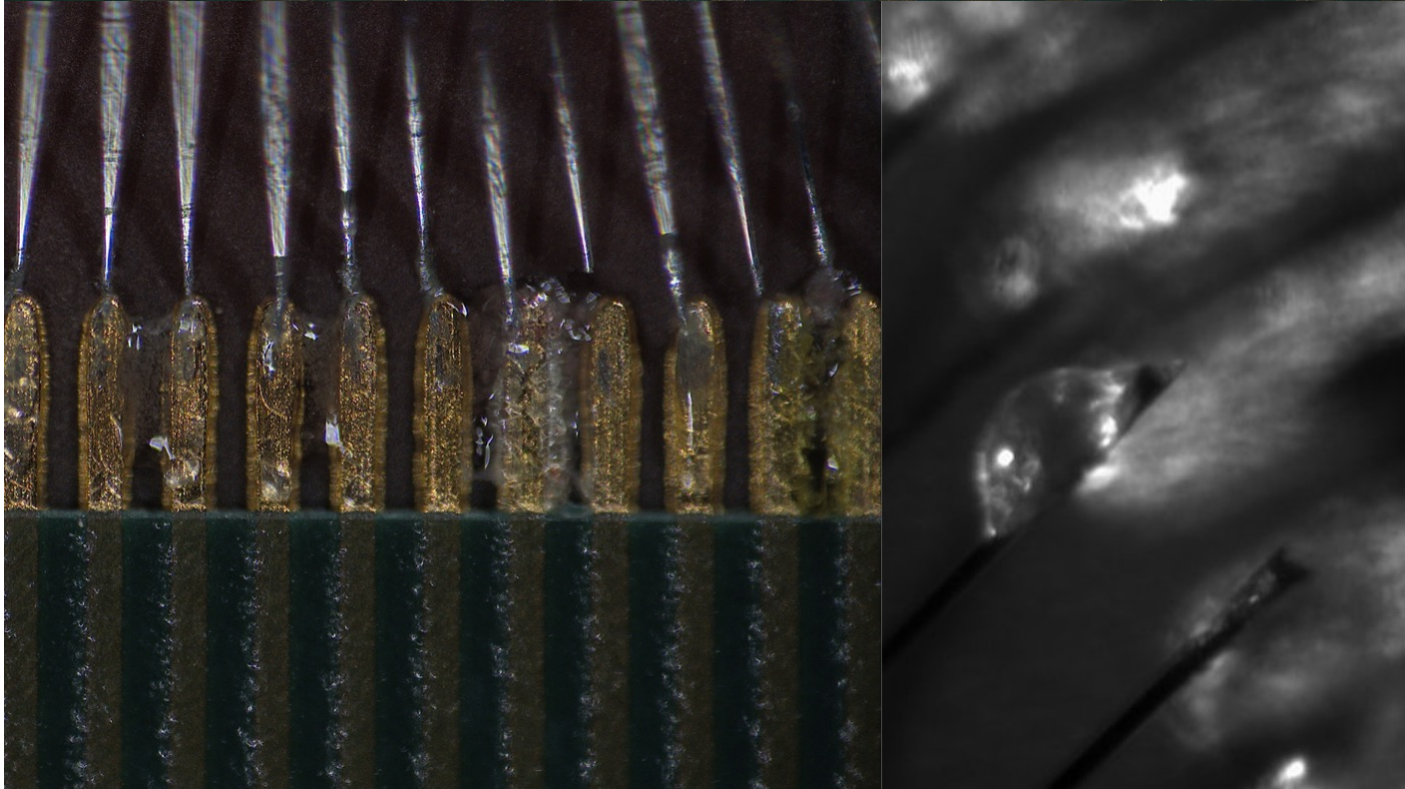
Broken wire bonds & crazed "dielectric(?)" on Jan 23 irradiated CROC at lower left

Foot lifts (one carrying "dielectric(?)" shard) 100s of um away from bond pads on irradiated CROC

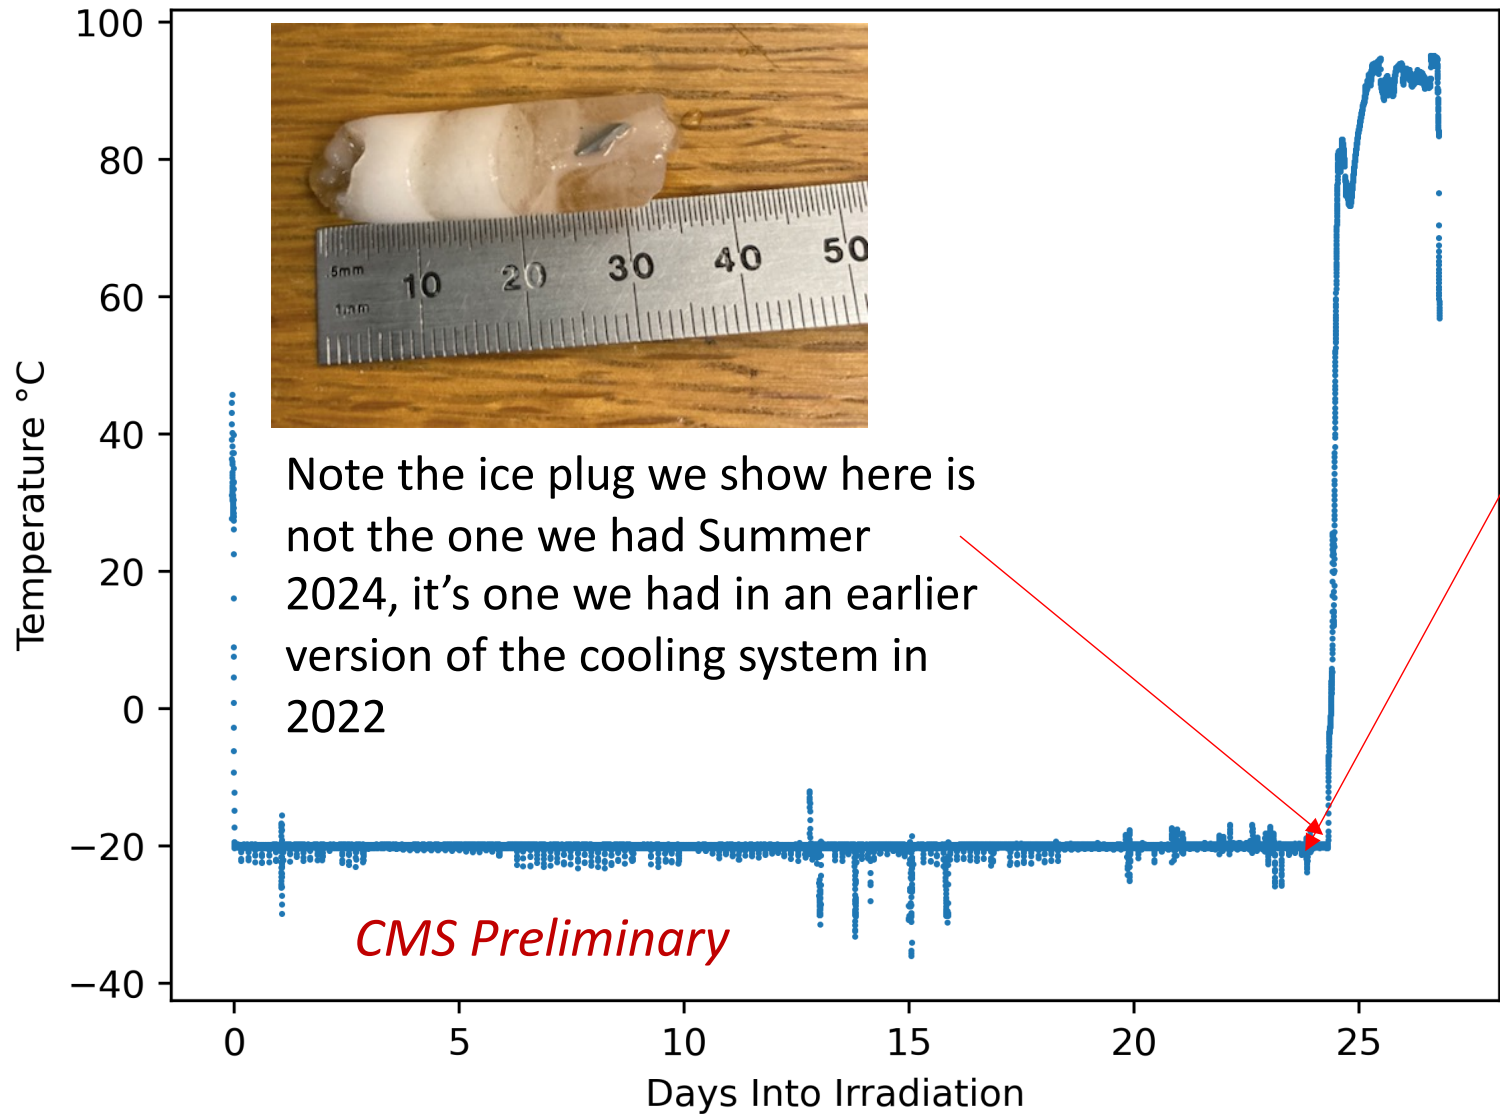
Ice Blockage Causes End Of Irradiation

Note the ice plug we show here is not the one we had Summer 2024, it's one we had in an earlier version of the cooling system in 2022

- Ice blockages forming from outside air finding its way into the gravity feed
 - Fixed over short-term using check valves to keep air out of system. However, never tested beyond two weeks. A redundant small dewar would have allowed us to de-ice the primary one while continuing irradiation.
