Silicon Detector Challenges

For the Nab Detector Review

October 26, 2023

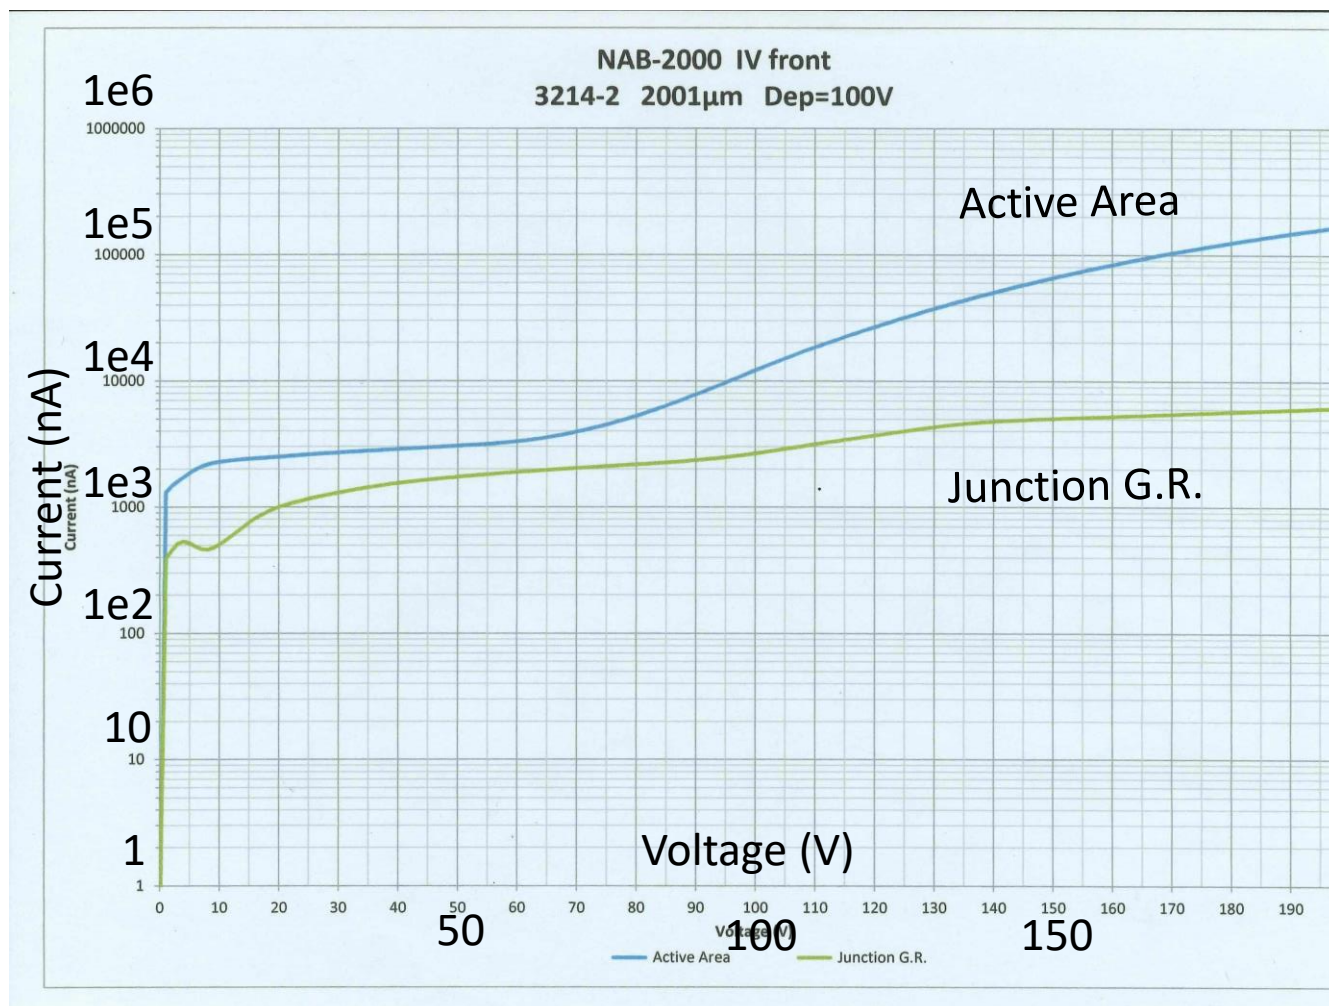
Data from Micron (at room temperature)

- Two detectors installed into spectrometer
 - Upper detector underwent extensive testing at Manitoba
 - Lower detector installed with wirebonds recently repaired by Micron
 - No low temperature or source tests on lower detector due to long turnaround
- After installation of lower detector:
 - Anomalously high leakage current
 - Negative pulses (assume from detector breakdowns – surface contamination?)
 - Prevents operation above -50V bias

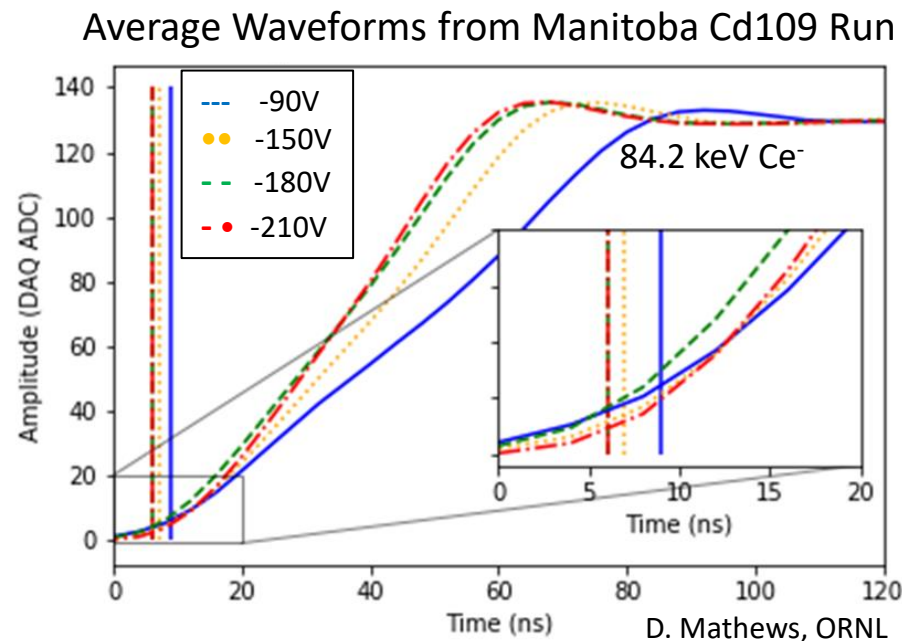
Consequences of Underdepleted detector

- Unable to fully bias detector before overwhelmed by noise
 - Ran at -50V for most data-taking
 - Distortion in waveform shapes
 - Not all pixels active!

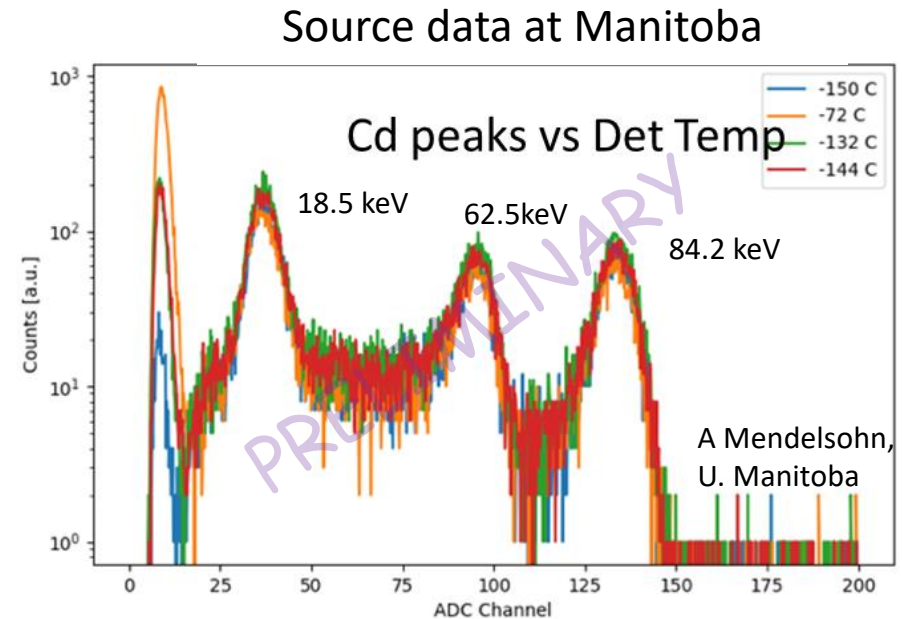
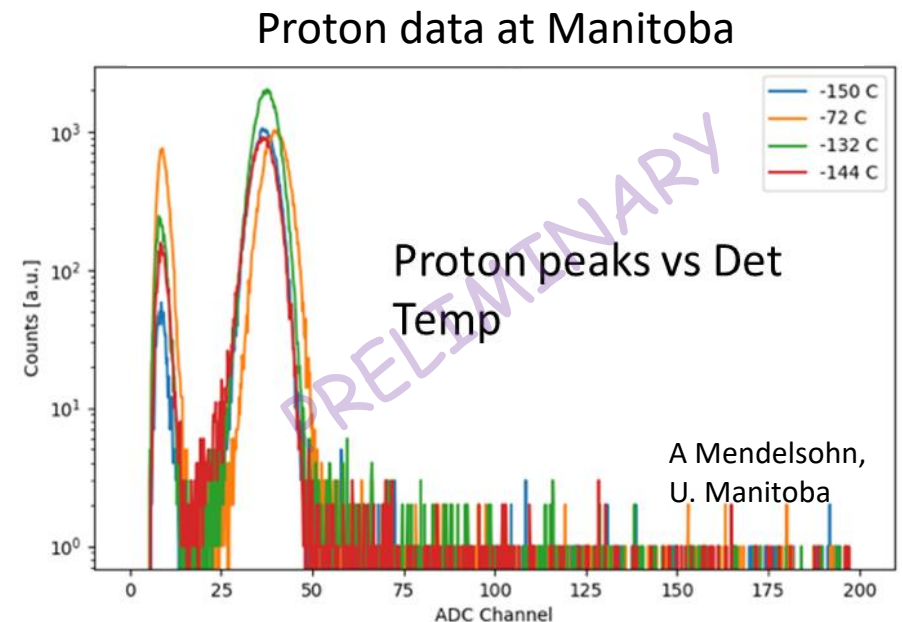
History of this Detector

- Characterized at LANL – wire bonds damaged (2018 – 2020)
- Wire bonds repaired at ORNL (June 2020)
- Characterized at Manitoba (2021-2022)
 - Proton peak at expected location
 - Used a beam of 30 keV protons
 - Different set of electronics
- Shipped from Manitoba to ORNL (May 2022)
- Installed in spectrometer May 2022
 - No data due to magnet failure
- Installed in test stand, calibrated with sources (April 2023)
- Installed in spectrometer, proton peak appeared much lower (May 2023 – now)
 - Calibration currently underway, investigating low energy

1. *Low energy calibration?*
2. *Ice buildup due to imperfect vacuum conditions (seen at LANL during Nab prototyping)?*
3. *Non-volatile contamination (not seen before in Nab, but other experiments have seen this as consequence of HV discharges)?*

- Low energy calibration studies underway
- We have attempted warming up detector to test for ice, but inconclusive.
- Attempts to assess deadlayer with alpha source ongoing, careful test stand measurements may be necessary

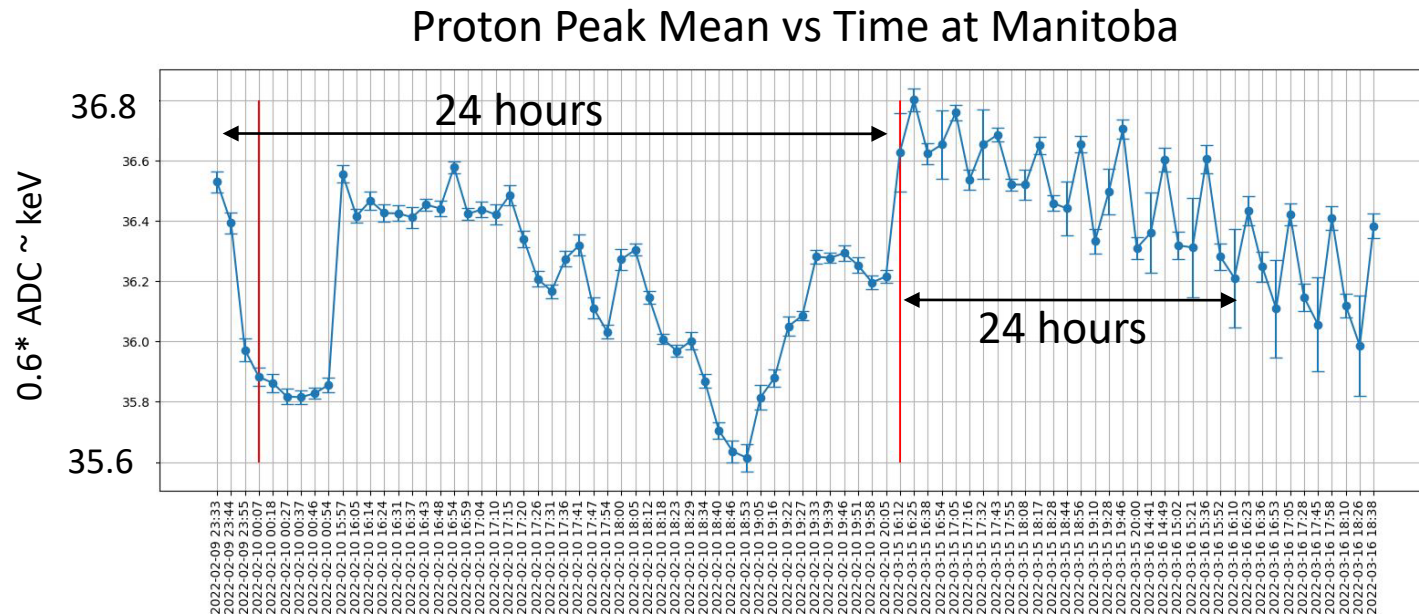
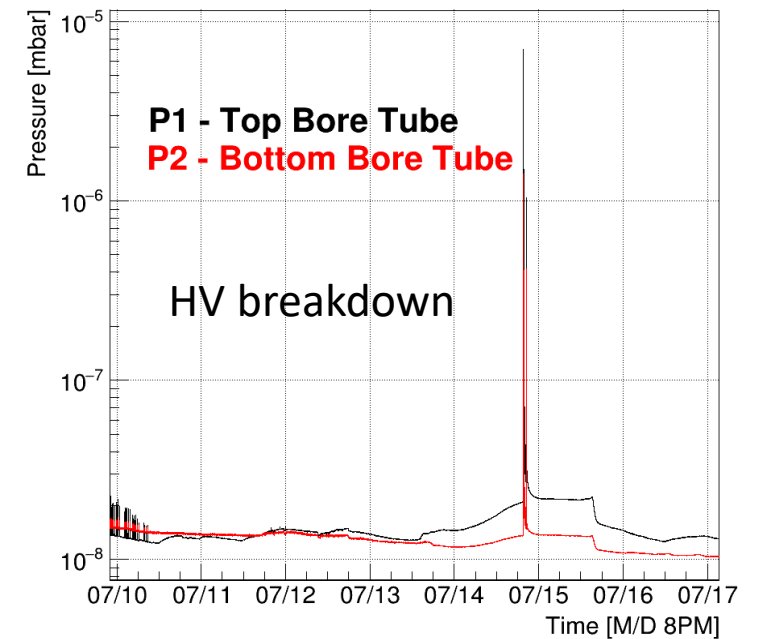
Could ice buildup be suspect in Nab

- Pressure at Manitoba $5e-9 - 1e-8$ mbar. Warm system.
- Nab spectrometer: $1e-8$ mbar (top) and $1e-9$ mbar (bottom); cold bore
- HV and SRSIS have caused pressure spikes

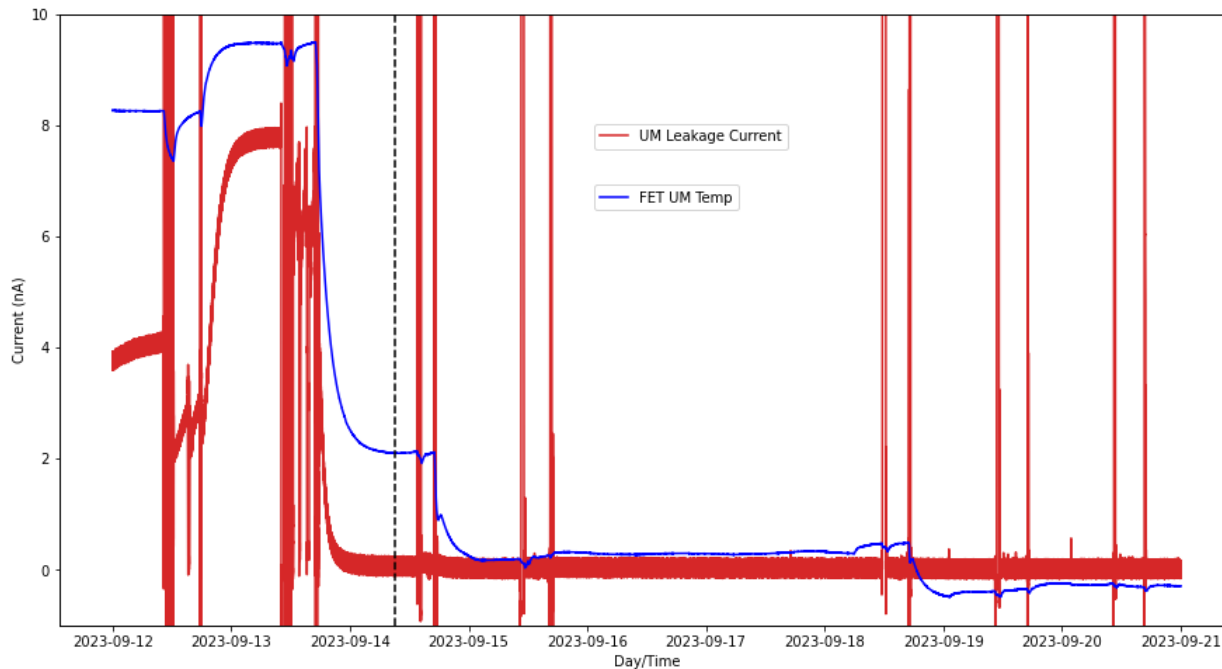
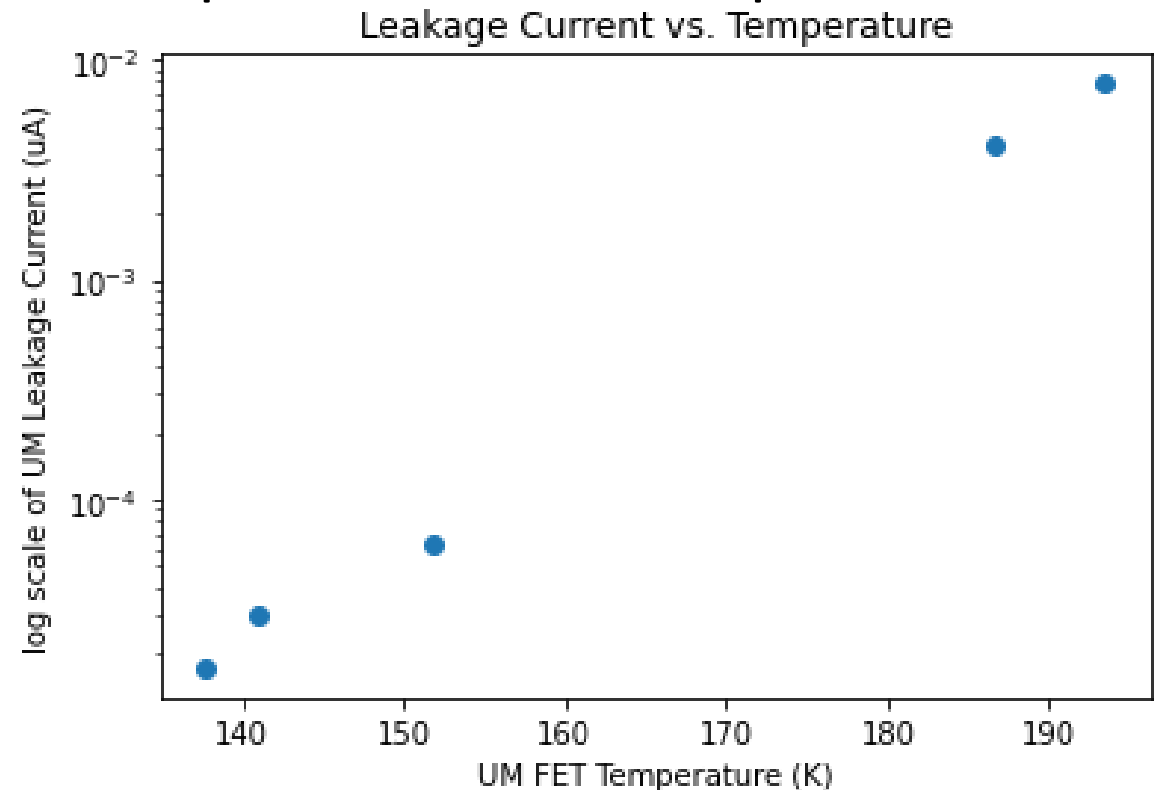
Leakage current vs temp

- Detector temp offset from FET temp
- Should be able to look at older data to compare detector temp time constant vs FET – Nick?
