# Connector Improvements

Chuck Britton, Nance Ericson, Kyle  
Reed, Emma Brown, Leah Broussard,  
Austin Nelson, Andrew Hagemeyer

8 Feb 2023

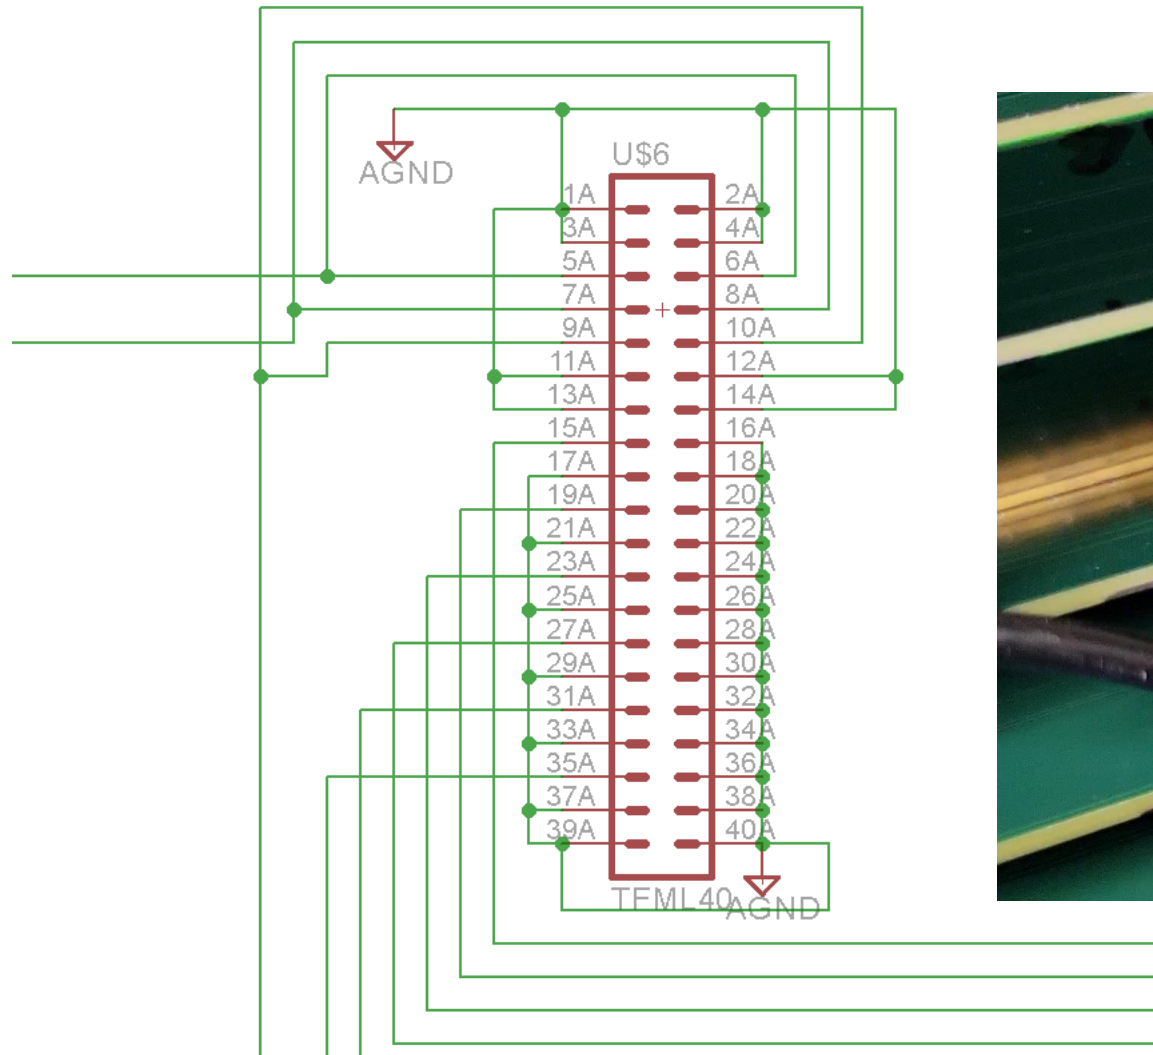
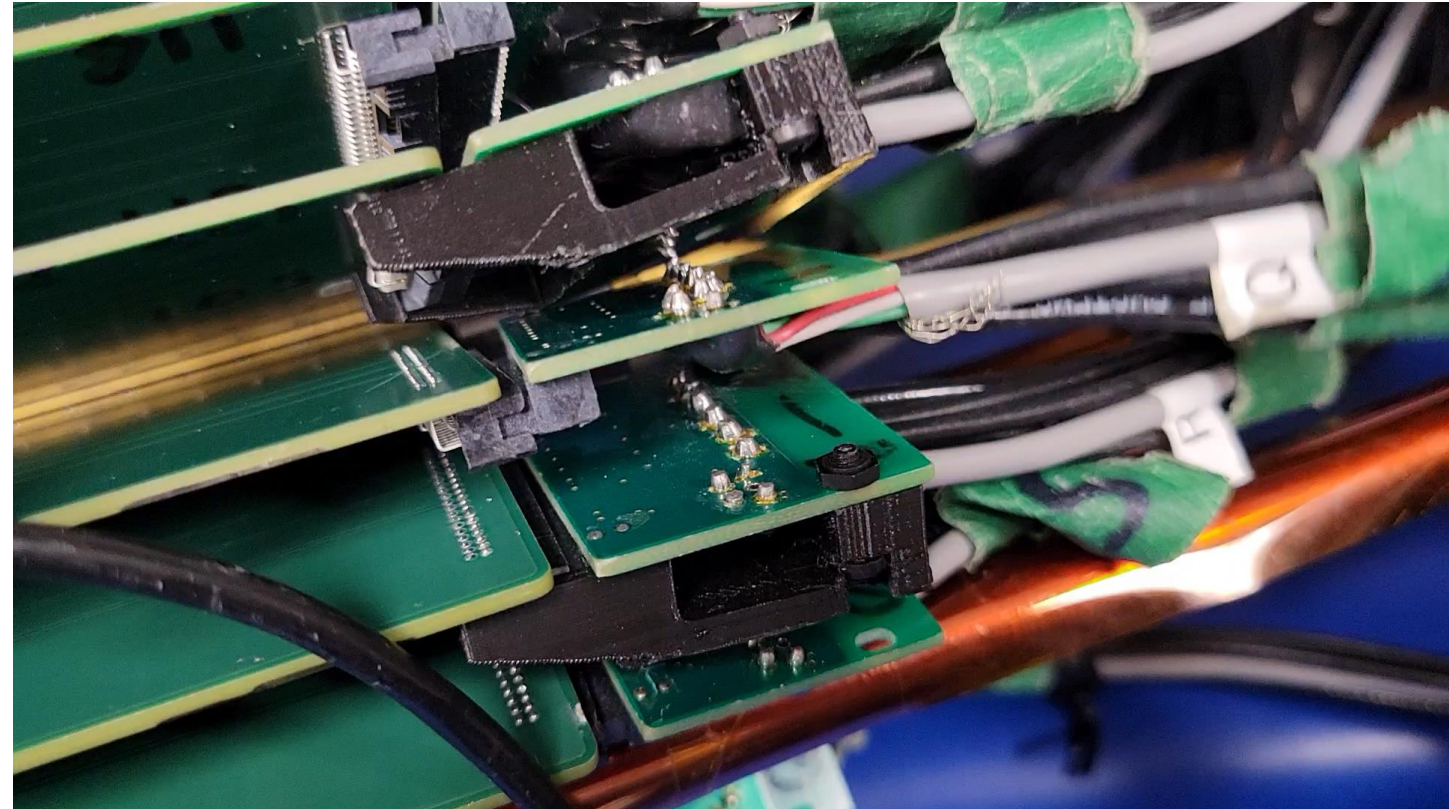
# Present connector

- Connectors have severe retention issues
  - Fall out easily
  - Slight movement causes partial or complete disconnection
  - Hard to put in for installers
- Connector is not appropriate for the signals
- Need to change to a connector or cabling that is more robust

Too small connector, too many grounds, easy to dislodge

- Two approaches have been considered
  - 1<sup>st</sup> would be to use a heavier-duty right-angle header with 0.1" pin spacing
  - This would allow cables to be connected requiring much more force and therefore more retention
  - Also would have better ground
  - 18" pigtail cables would then be connected to these prior to installation making assembly much easier
  - 2<sup>nd</sup> would be to solder pigtail cables directly to each board.
