^{60}Co γ Irradiation of a CMS CROC v2 to 1.6 Grad

VERTEX 2025
Knoxville, TN
August 25-29, 2025

Steve Wagner (University of Colorado, Boulder)
For the CMS Tracker Project

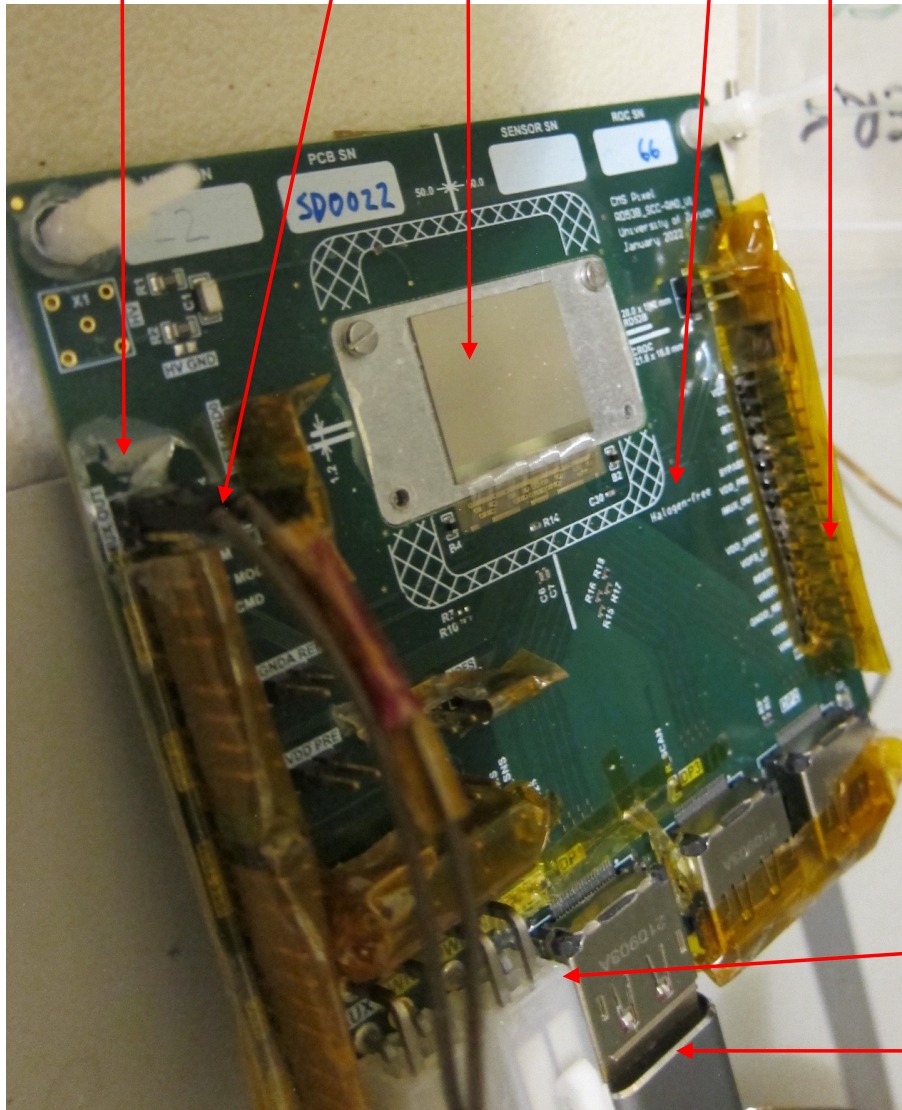
Undressed CROC and Transfer Line

CROC with wire bonds
Mux (V & I) data
Torn parylene

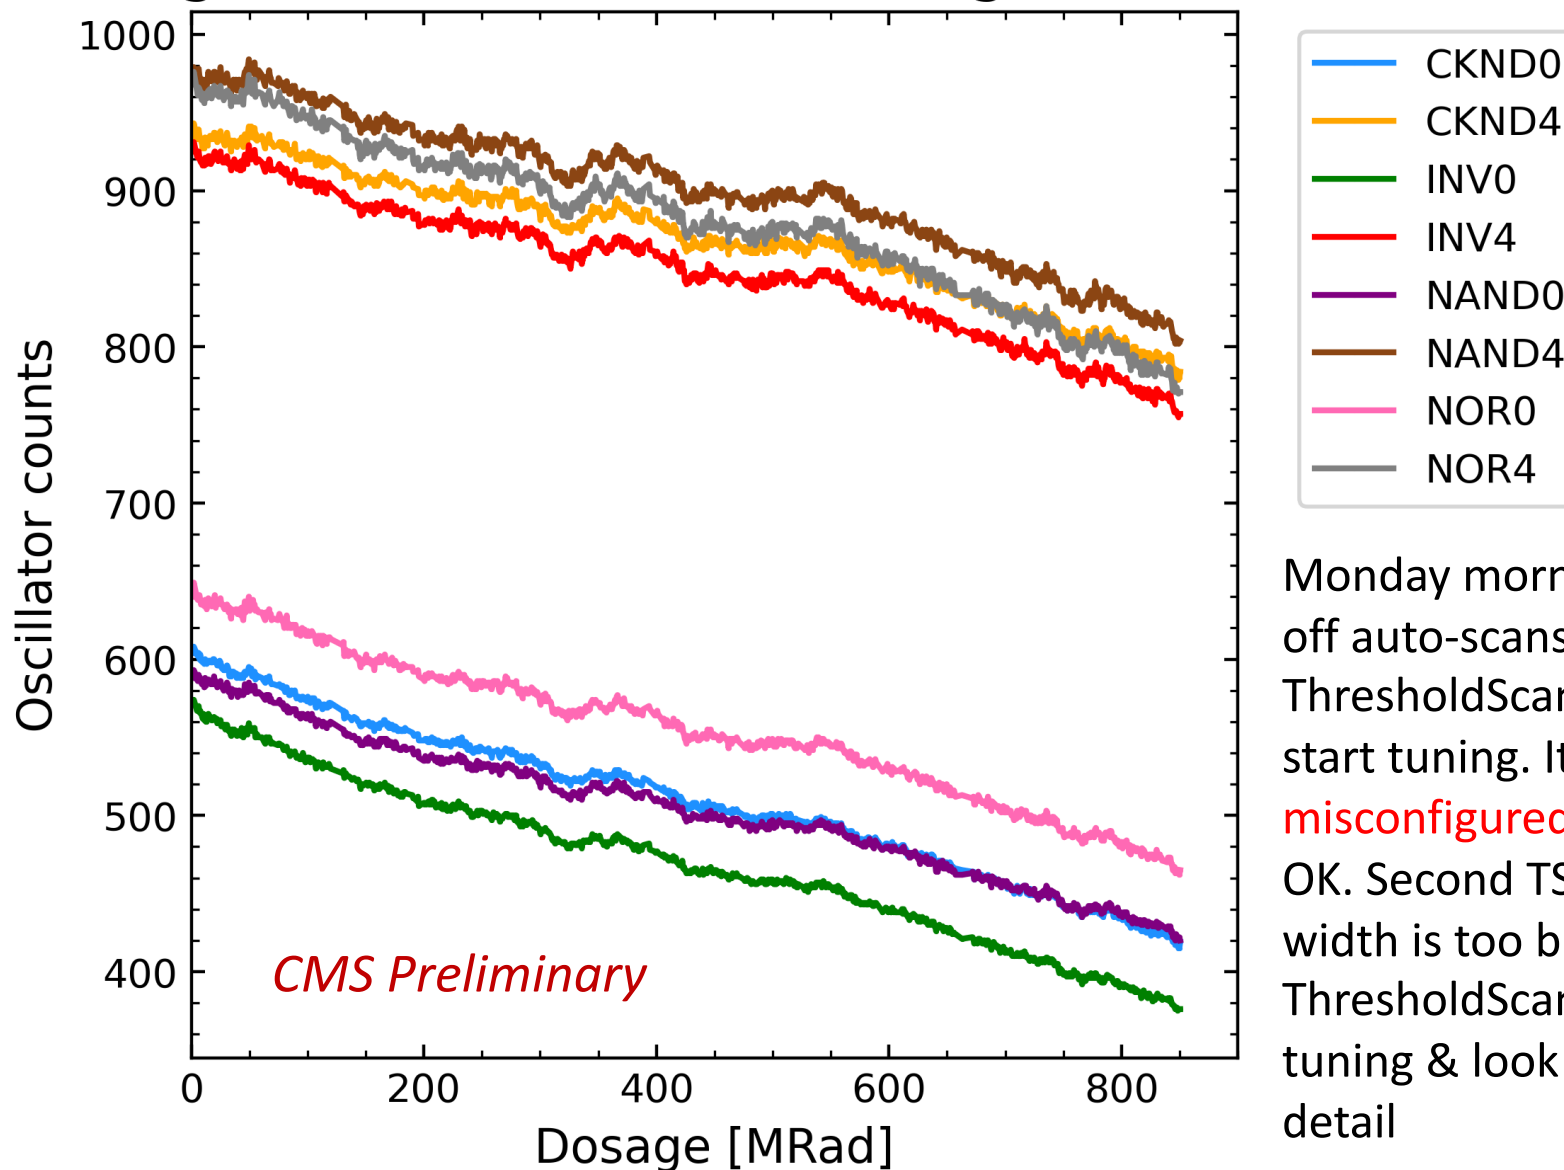
Ring Oscillator Bank A During Irradiation

Monday morning looks fine – turn off auto-scans & run a ThresholdScanFast before we start tuning. It fails – **PS are misconfigured** – cycle & they're OK. Second TSF runs fine, but width is too broad. Run ThresholdScan before starting tuning & look around in more detail

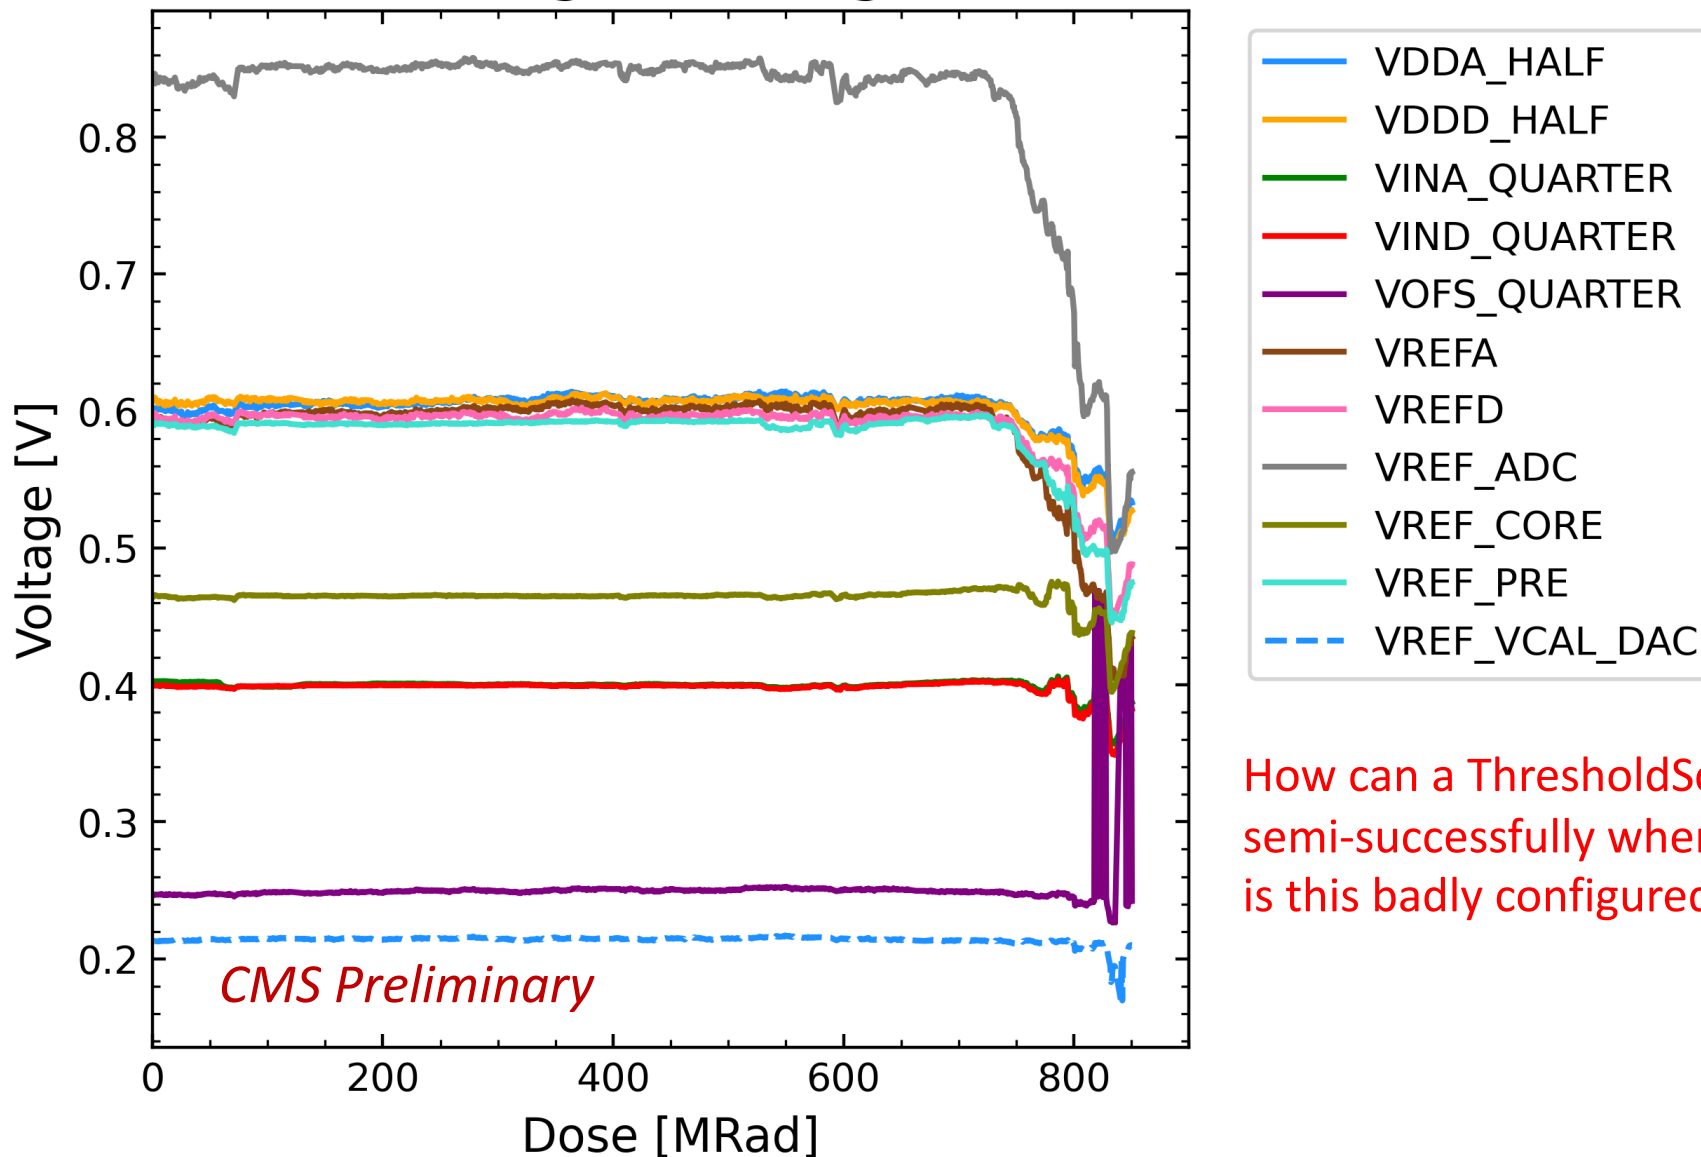
External Voltages During Irradiation

After 730 Mrad a splice in the cable carrying MuxScan data deteriorated, & about half the Mux data corrupt. Also caused "occasional" failure of MuxScan with misconfiguration of CROC voltages. Now can completely reproduce problems in lab, but recovering good data is difficult – ongoing work. Other than misconfigurations (which were reset) did not affect operation of CROC

At this point 2 scenarios presented themselves: *either the CROC was badly configured, or the MuxScans were lying*

Since the ThresholdScans were running (just not well tuned), and VINA & VIND no longer tracked with the supply readings, we tended to favor the "lying MuxScans." But needed to retrieve the second shifter from the Sandia badging office, where they had spent the morning, & when we got back, we had decided to attack the "misconfigured CROC" first

To raise the Vs, we had 2 levers. One was the PS Vs, and the other the software trims on VREFA and VREFD. We changed the PS Vs first (easiest) – moving them up to ~2.0 V seemed to move VINA & VIND back to 1.6 V, where they should be.

VREFA, VREFD, and VREF_PRE were still not back where they needed to be, and we needed to move VREFA_TRIM & VREFD_TRIM to 15 to get them close (they had been at 7 & 10 for the entire irradiation up to that point). The CROC would not function with these, so they were backed down to 11 & 14. The auto-scans had been long suspended at this point, & we went back to Threshold tuning

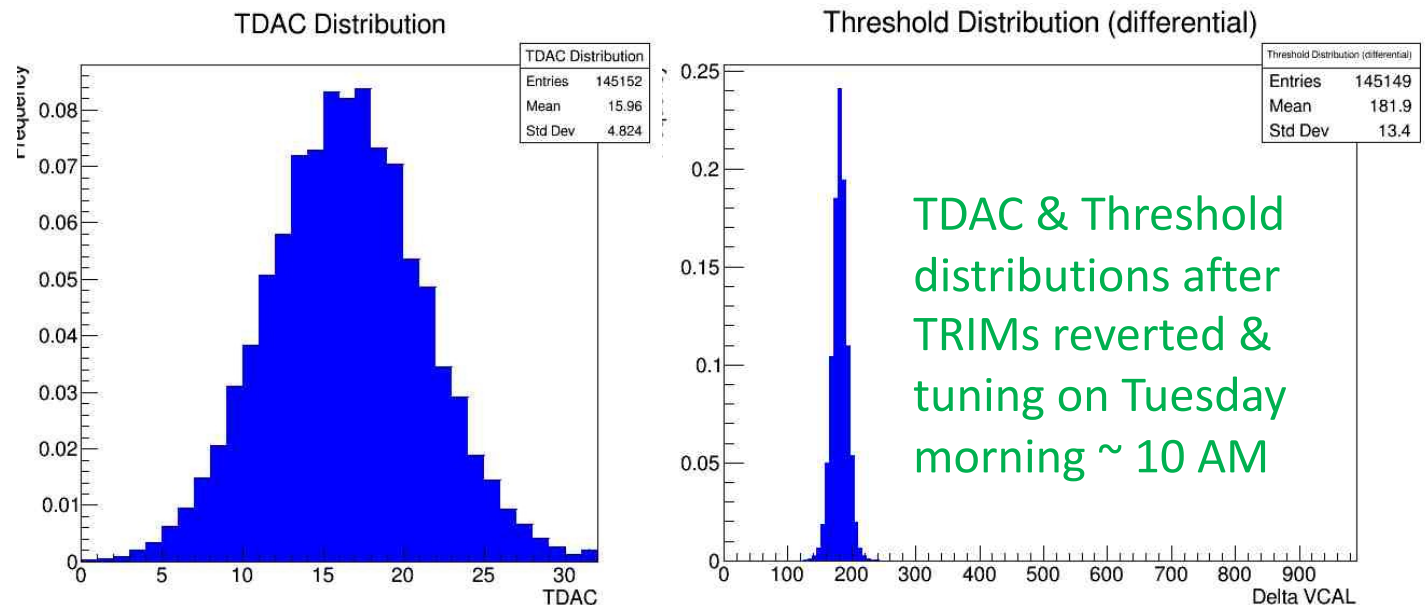
Discussions with Flavio Loddo very early in the morning (our time) Tuesday brought us back to the idea that it was the MuxScan that was lying to us

“Nothing should be working if VREF_PRE is less than 0.5 V.”

Came into GIF to find RingOscillators and AnalogScans all over the place, PS currents oscillating. Reverted VREFA_TRIM=7 & VREFD_TRIM=10 & reset, and everything went back to normal (except MuxScan still failing frequently). Were able to tune Thresholds (after one mis-step that was obvious & quickly backed out)

Were able to run like this all day & overnight, but had no idea what Vs on the CROC were (call this “flying blind”)

Pretty much “flew blind” until we passed 1 Grad (next day) and could drop the cell & access the thermos (tho kept up Threshold tuning as our “quality check”)

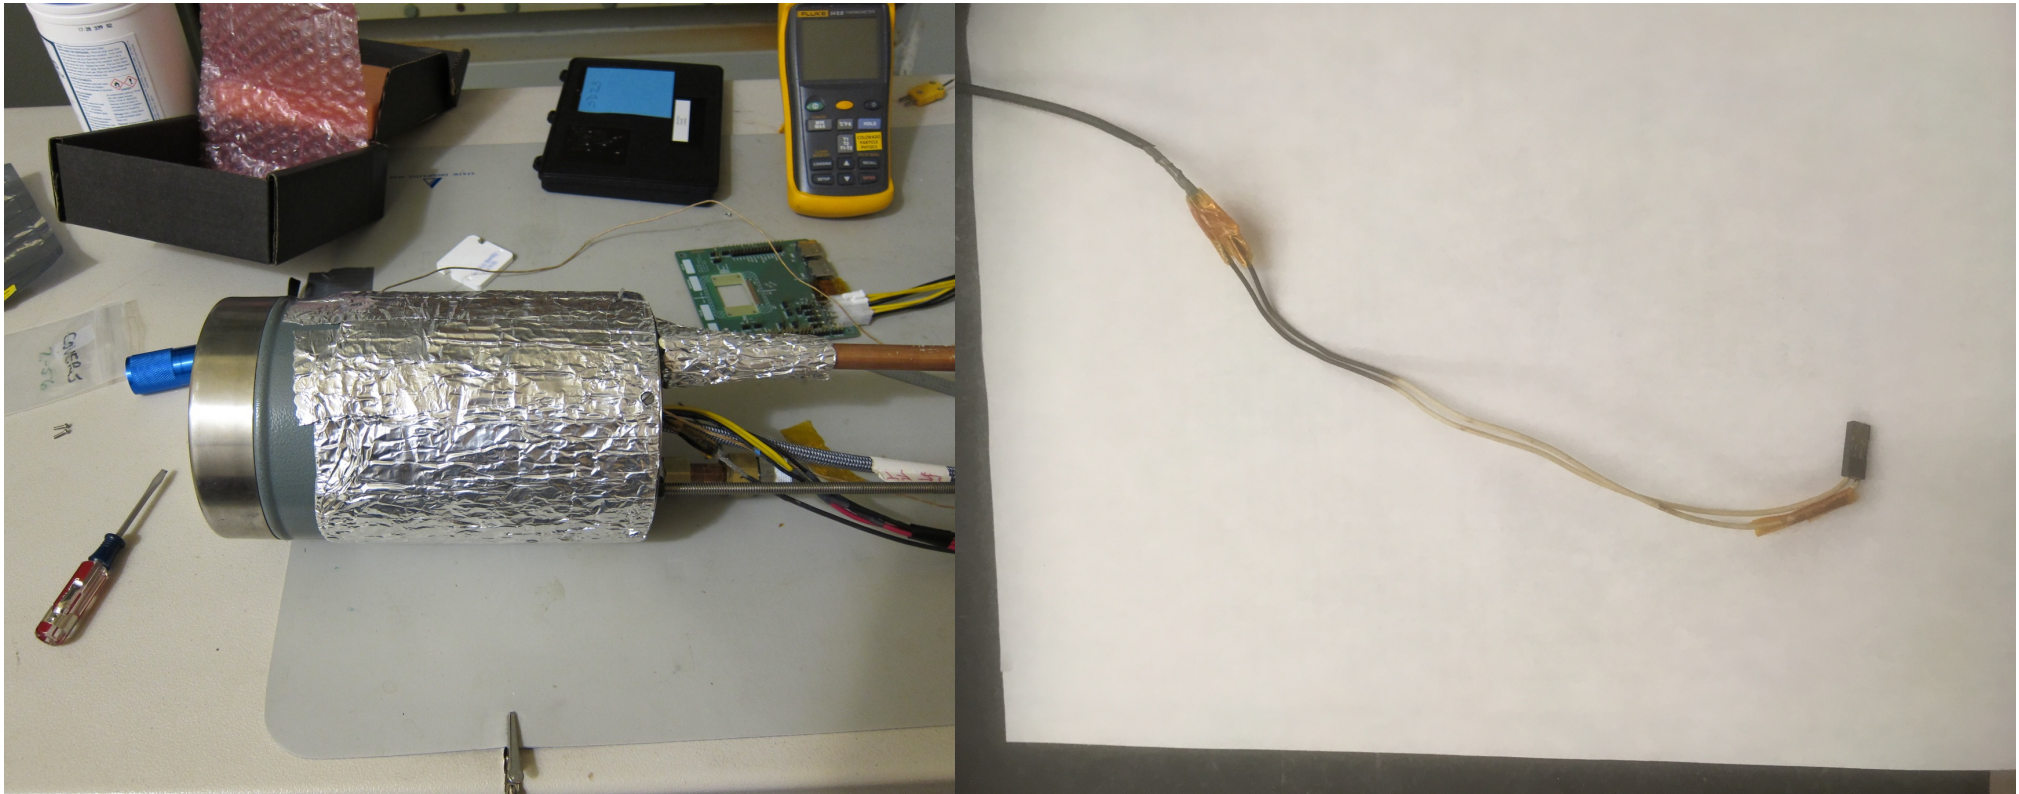
Try to Fix the MuxScan Cable Splice

On the drive to Sandia on Wednesday morning, we agreed that any problem with the MuxScan cable would almost certainly be where 2 cables were spliced together right outside the thermos. We did not want to open the thermos & replace the cable because SCC (& everything) becomes brittle with irradiation. So we decided to try to fix the splice first. **First MuxScan ran fine** but **next 4 had problems. Decided to close up & run overnight again without MuxScan**

We came in the Thurs morning deciding if we should drop the cell & open the thermos. We ran MuxScan and it worked fine several time – added back to auto-scans, even overnight.

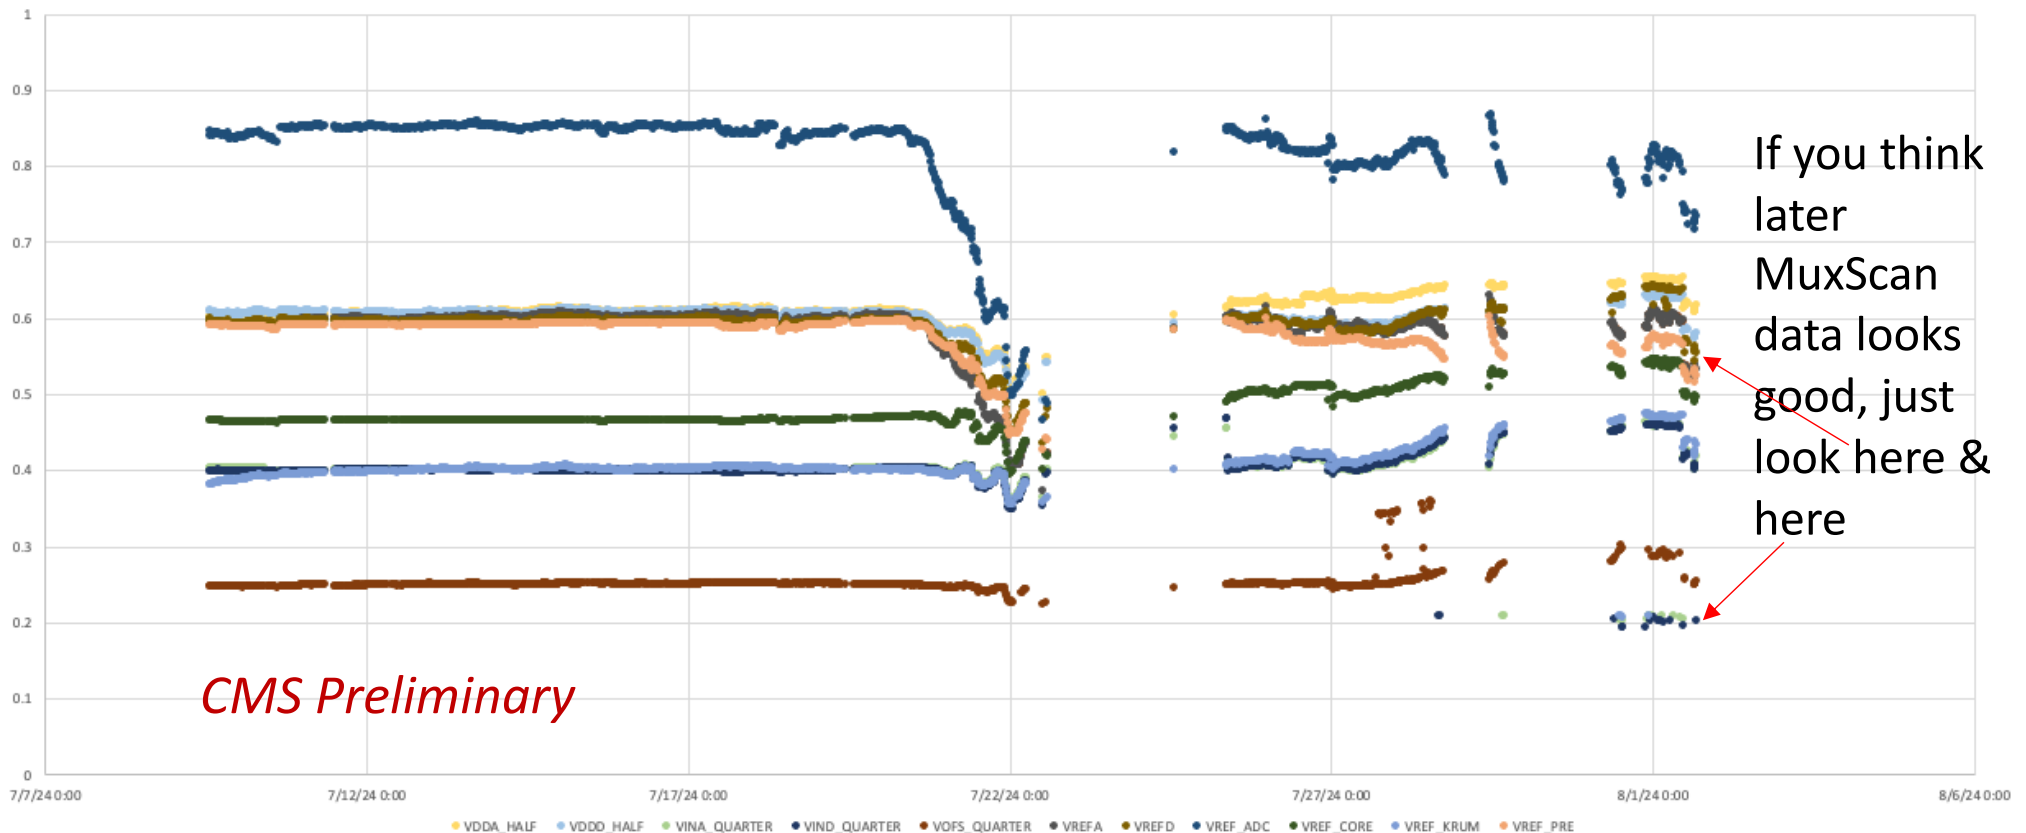
Thru the Last Week of Irradiation

New shifters came in on Monday morning to find auto-scans dead & CROC misconfigured by failing MuxScans (just like week before). This happened a few more nights (+ one night spent running ThresholdScanFast in place of MuxScan). But threshold tuning fine until 4:15 PM Friday

Also had problems getting LN2 from the big dewar into the small dewar (presaging the ice blockage on Friday night that ended the irradiation & fried the CROC). But there's always enough LN2 in the small dewar to keep the T control working fine (until Friday night)

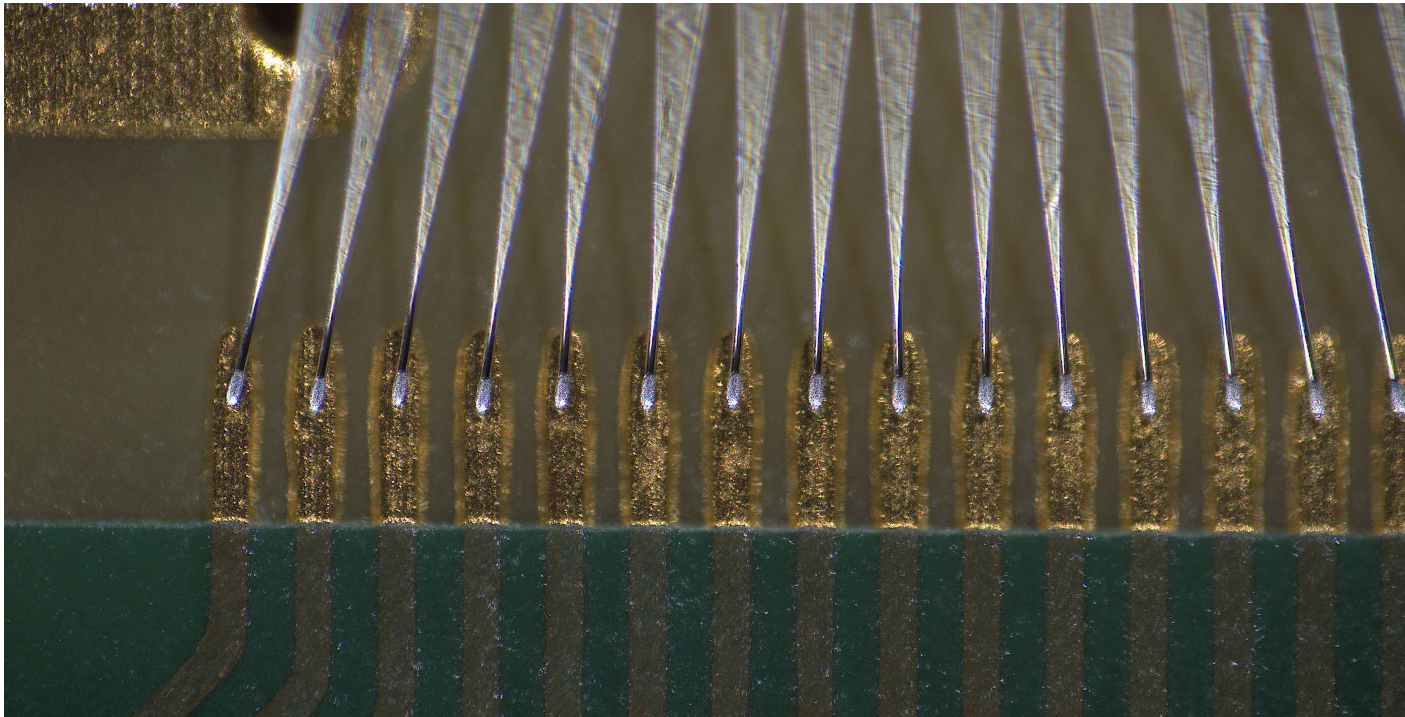
Microscope picture of unirradiated wire bonds on card (top)

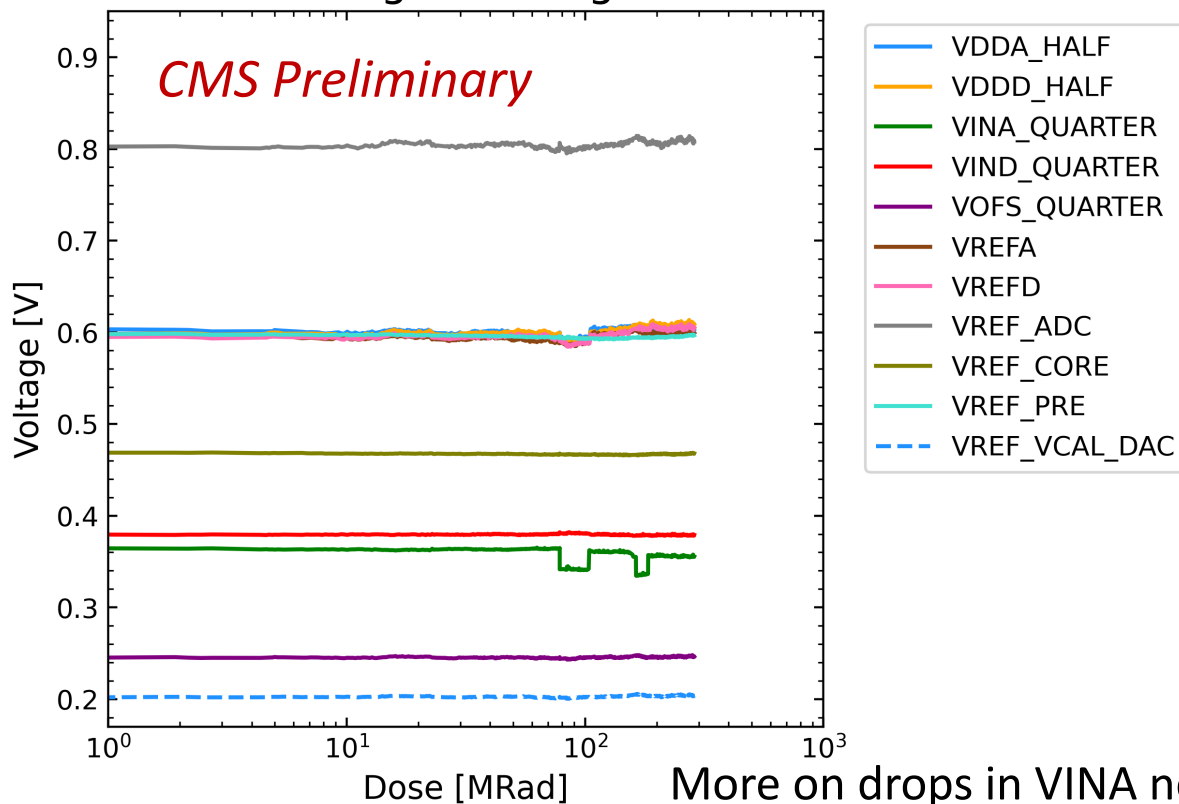
External Voltages During Irradiation

γ-ray irradiation

More on drops in VINA next slide.

Some voltages (like VREF_ADC) changed significantly by ~300 Mrad & we should have seen this.

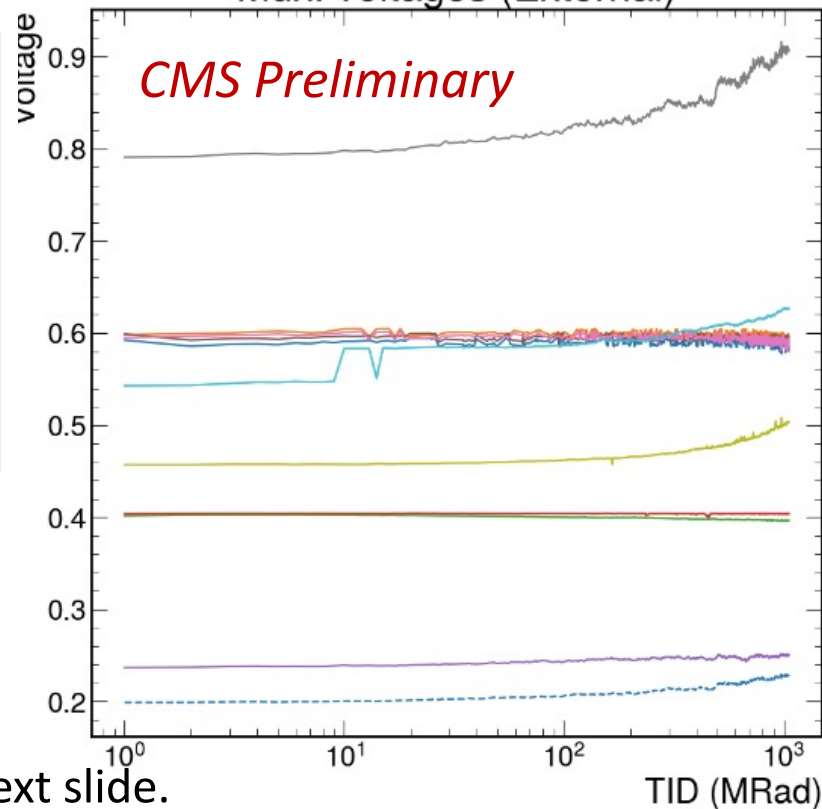
Mux: voltages (External)

x-ray irradiation

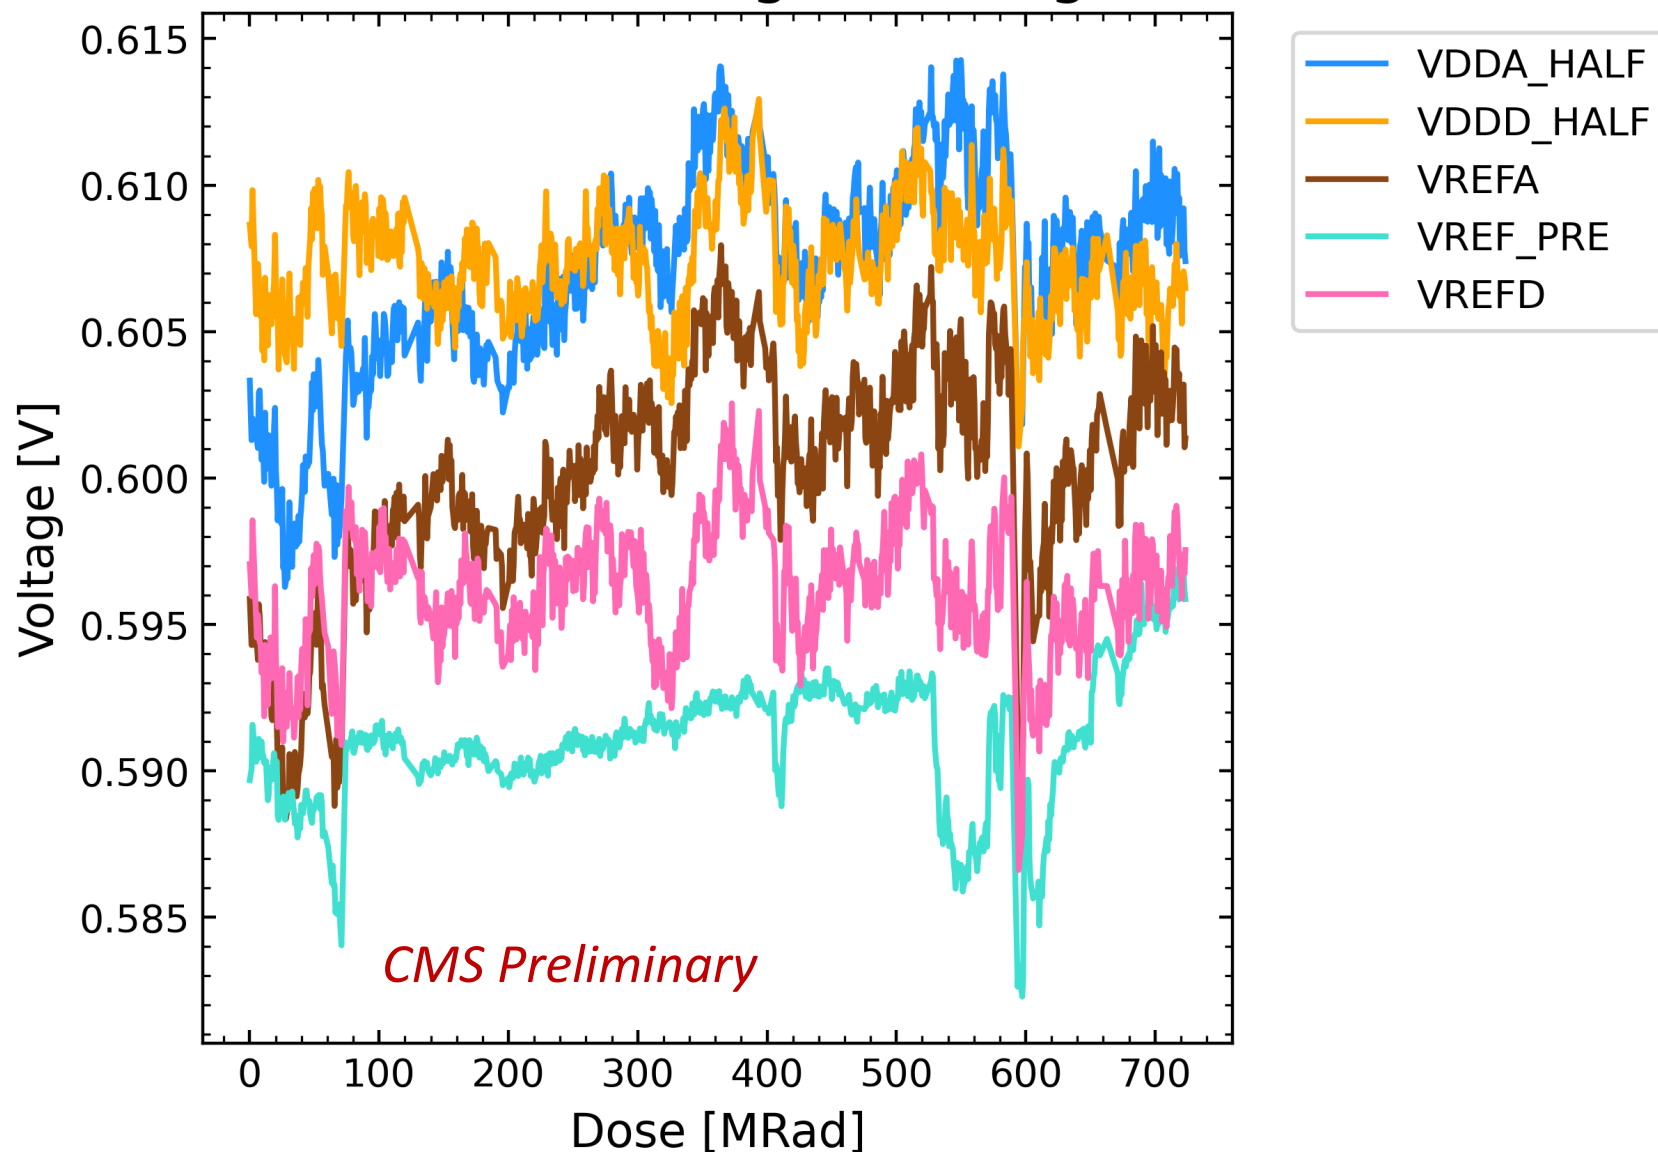
Subset of External Voltages During Irradiation

Blow-up of 0.6 V Region to 730 Mrad

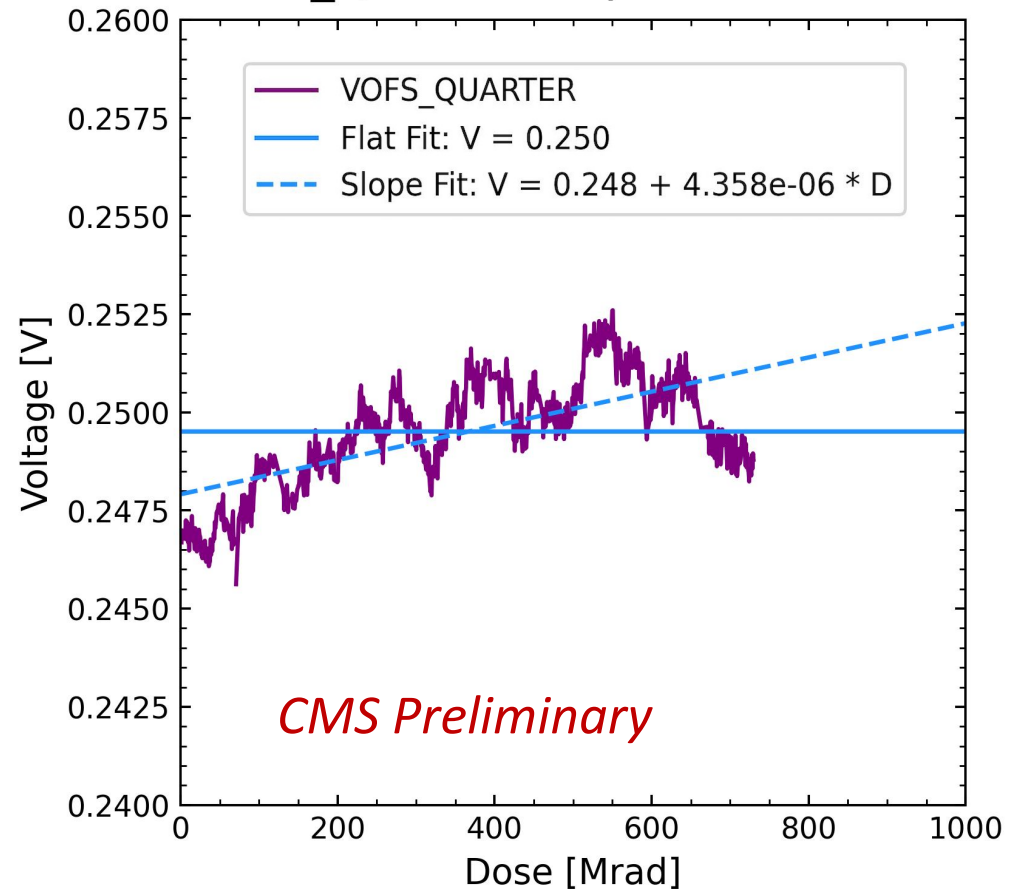
VOFS_QUARTER up to 730 Mrads

VOFS is the CROC proxy for Iref. Set jumpers on irradiation card so VOFS_HALF (measured on PIN block) reads 0.5 V. MuxScan reports VOFS_QUARTER

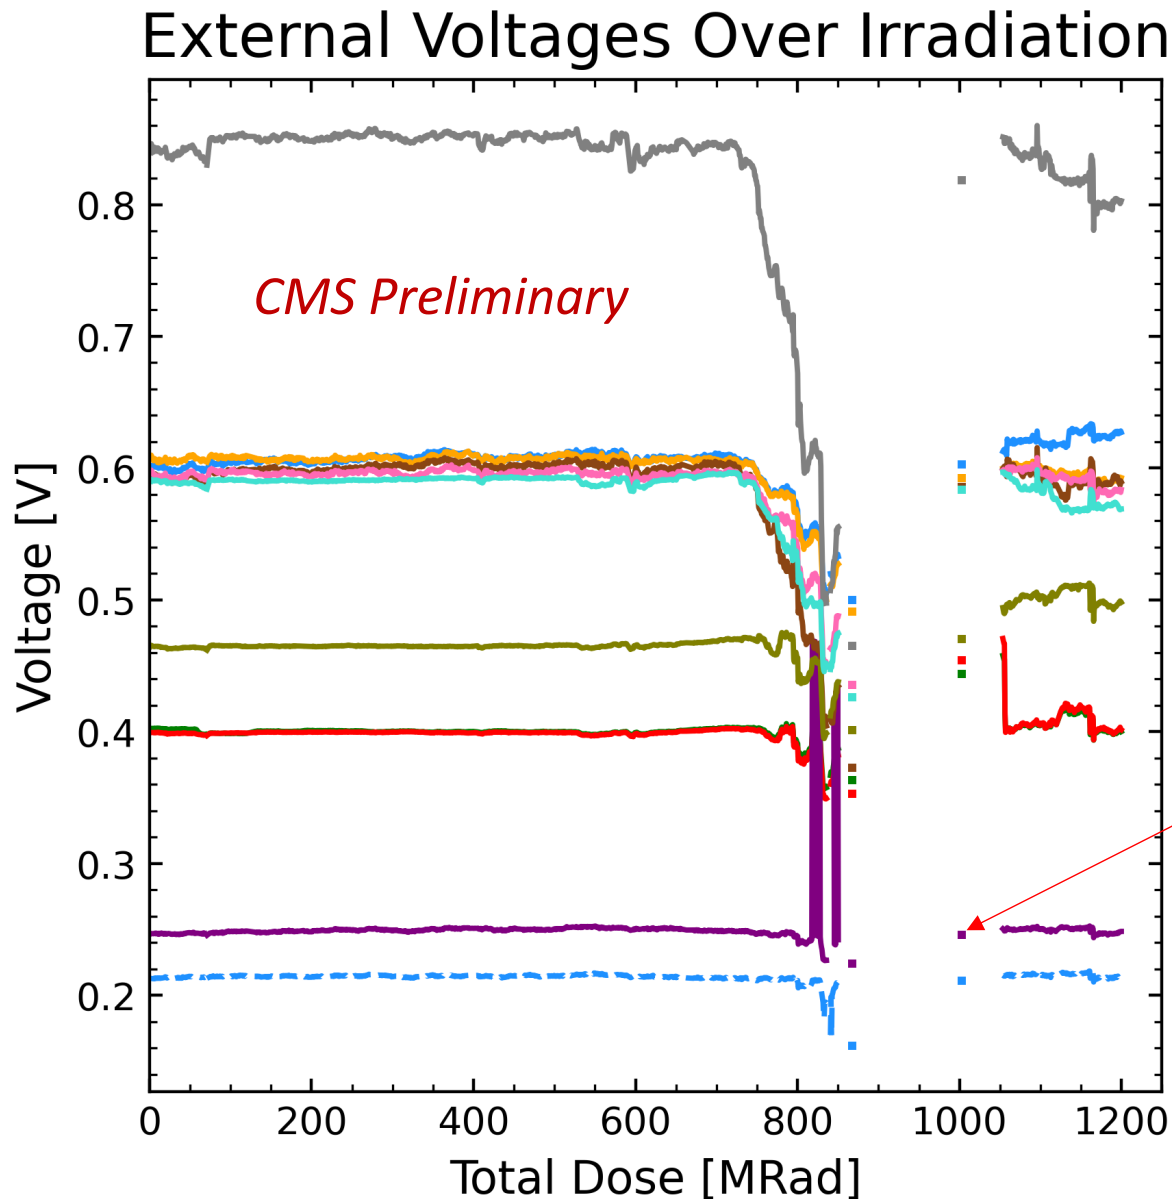
Irradiation to 1.2 Grad

Data from the 1 successful (manual) MuxScan taken while array was down & we were trying to fix the MuxScan cable splice (at ~ 1 Grad)
